**OSPREY COVE FIFTH ANNUAL  
MONITORING REPORT**

SFWMD Permit #36-04886-P

Lee County D.O. #2004-00207

OCTOBER 2016

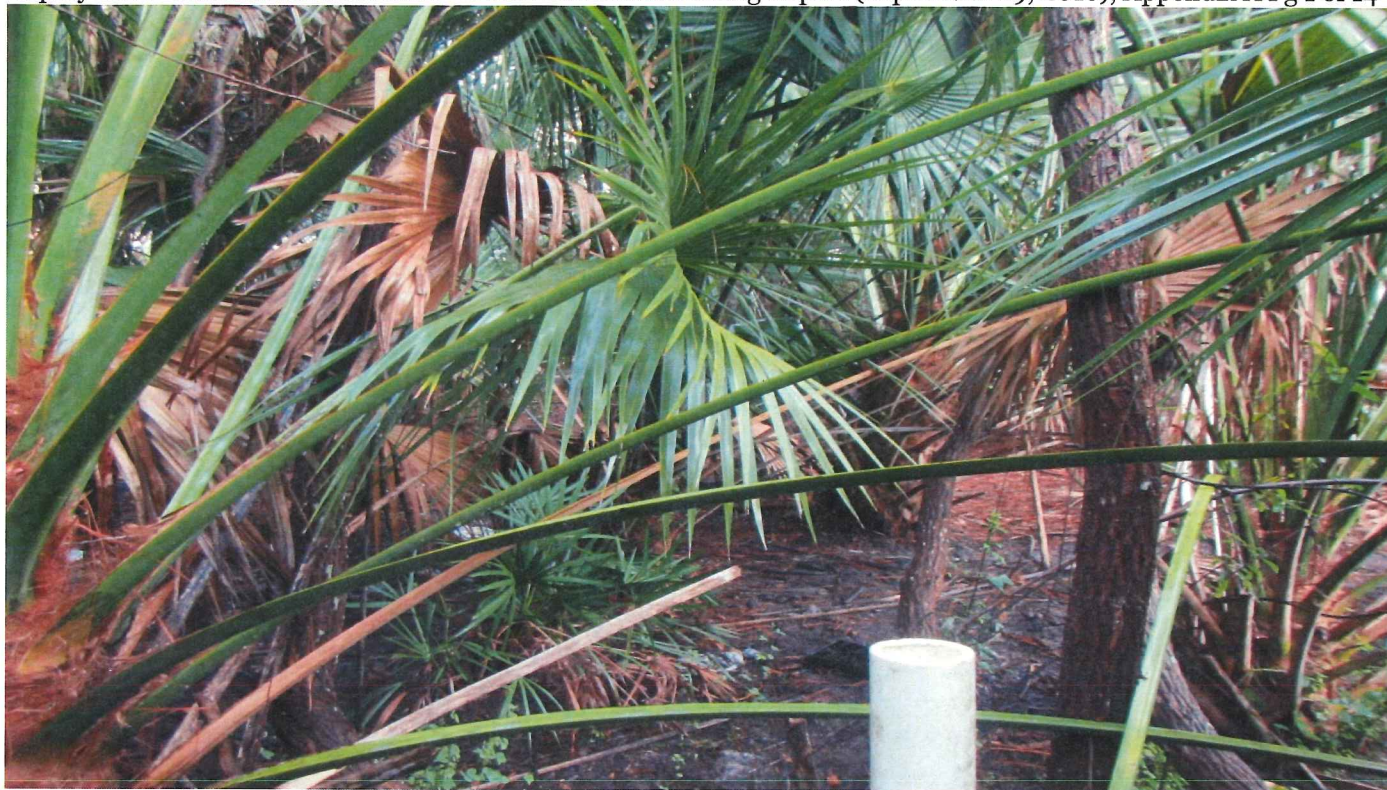
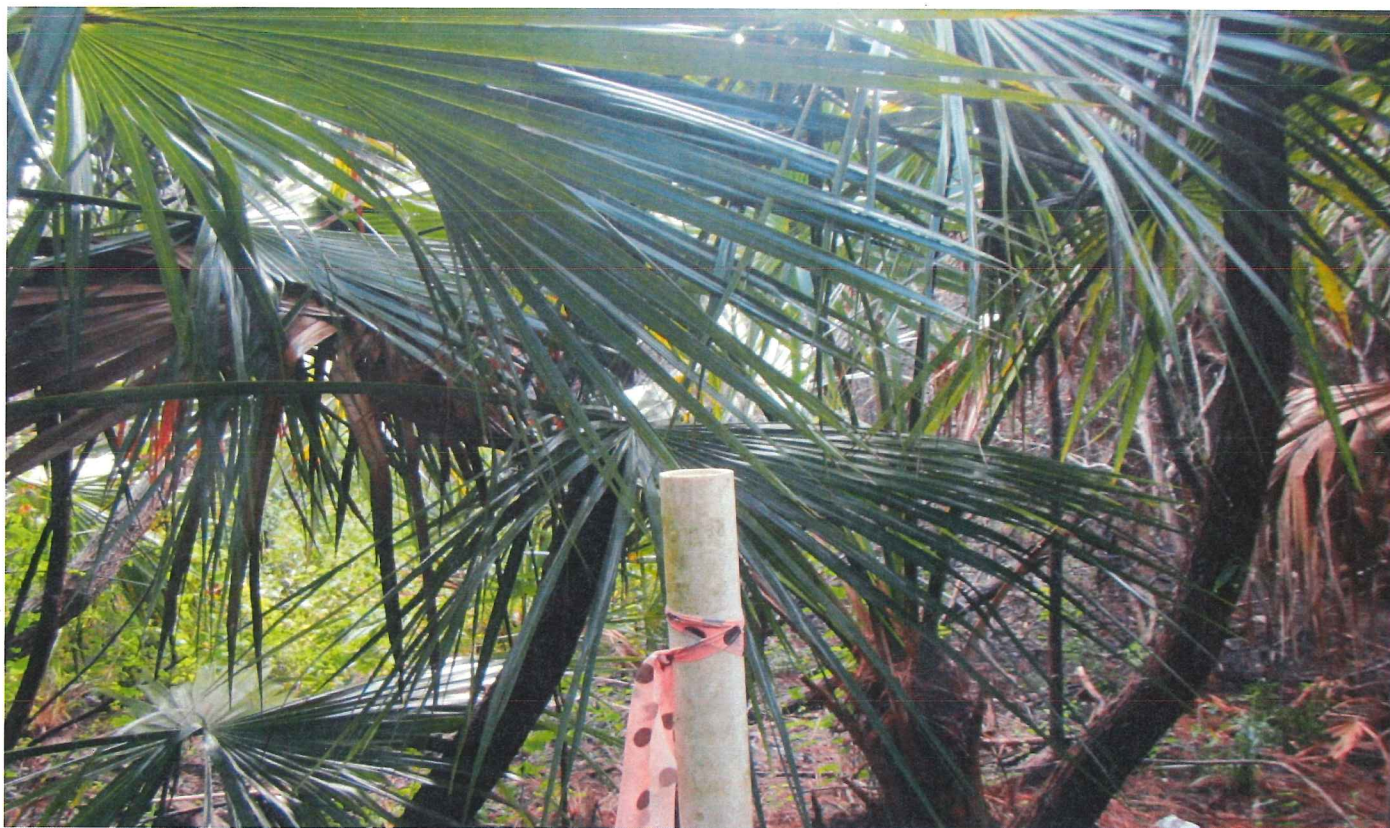
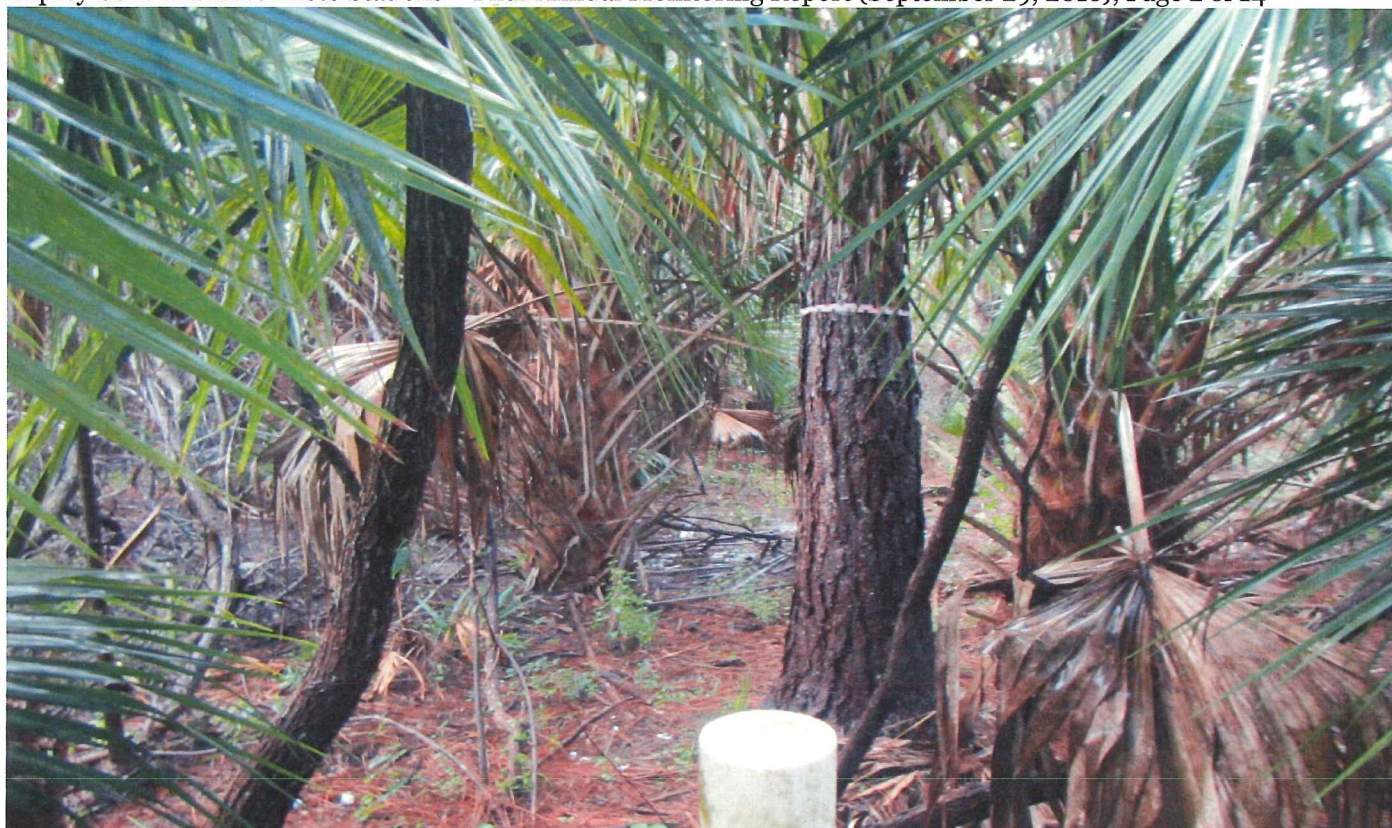
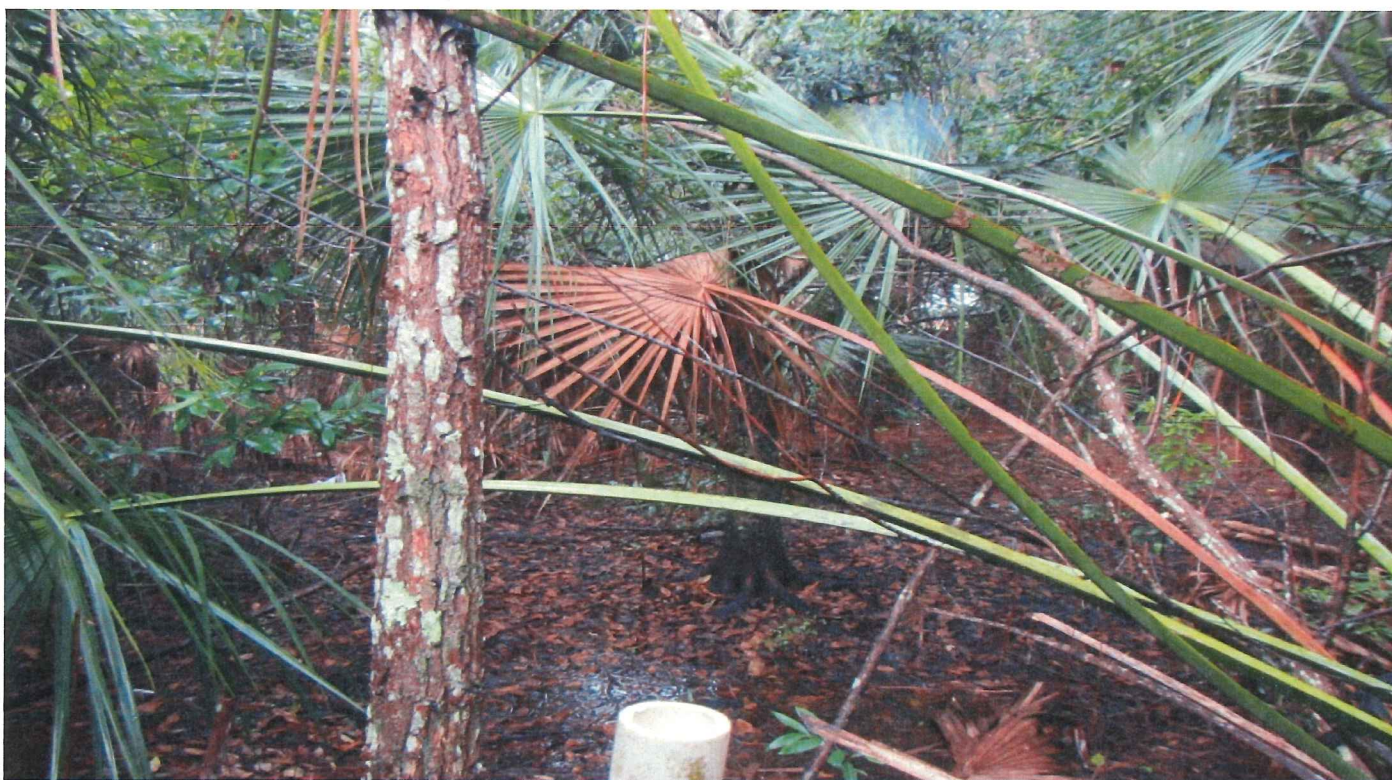
The planted vegetation in the vicinity of Photo Station #1 included slash pine (*Pinus elliottii*), laurel oak (*Quercus laurifolia*), live oak (*Quercus virginiana*), dahoon holly (*Ilex cassine*), cabbage palm (*Sabal palmetto*), red maple (*Acer rubrum*), cypress (*Taxodium distichum*), and Carolina willow (*Salix caroliniana*). Planted shrubs in this area included wax myrtle (*Myrica cerifera*), buttonbush (*Cephalanthus occidentalis*) and beautyberry (*Callicarpa americana*). The western end of Transect 1 is located in an area that was planted with upland and transitional species. The eastern end of Transect 1 is located in a lower depressional elevation that was planted primarily with wetland species. Herbaceous species observed on the transect included cordgrass (*Spartina bakeri*), red root (*Licanthes caroliniana*), carpetgrass (*Axonopis affinis*), flat sedge (*Cyperus odoratus*), coinwort (*Centella asiatica*), swamp loosestrife (*Hydrocotyle ranunculoides*), swamp fern

Transect #1 - Photo Station #1 – Looking North

Transect #1 - Photo Station #1 – Looking East

Transect #1 - Photo Station #1 – Looking South

Transect #1 - Photo Station #1 – Looking West

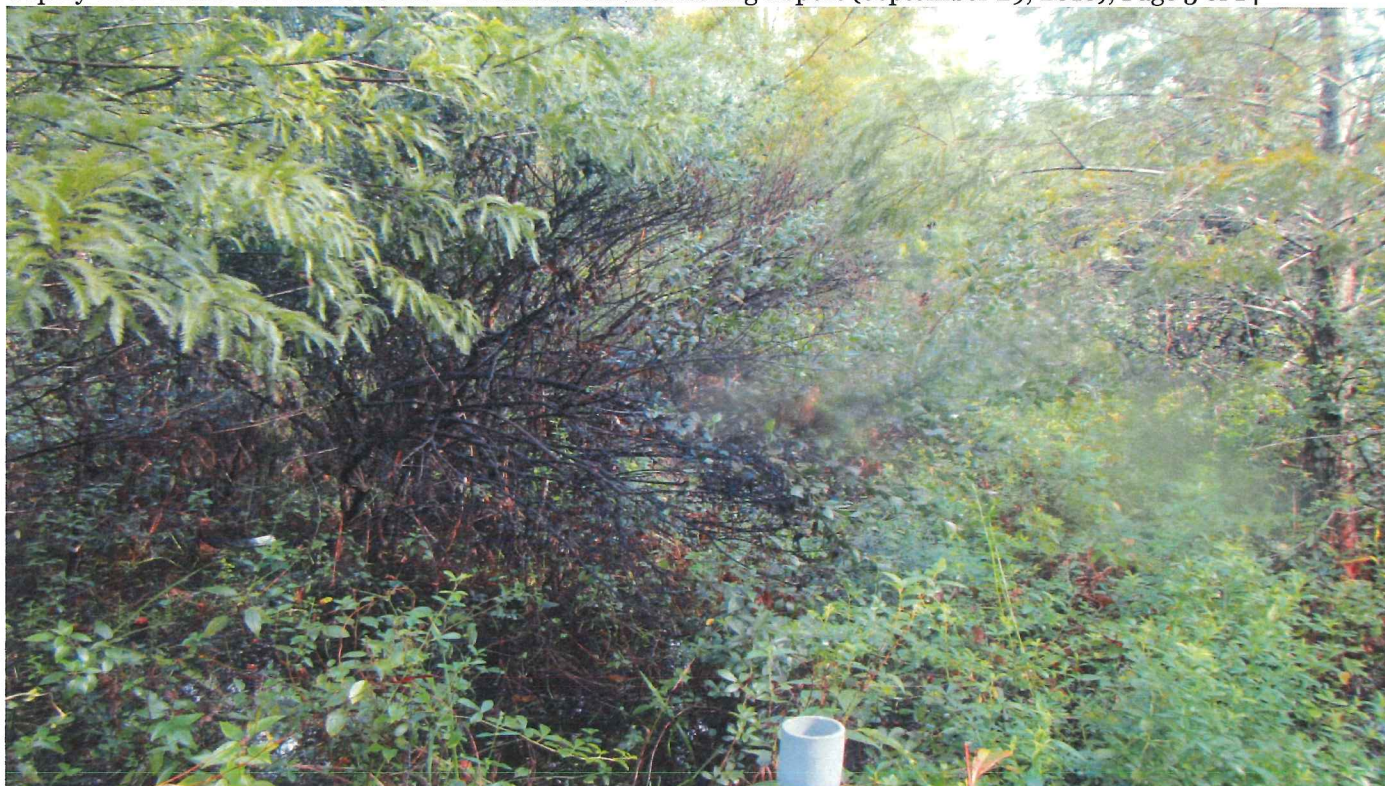
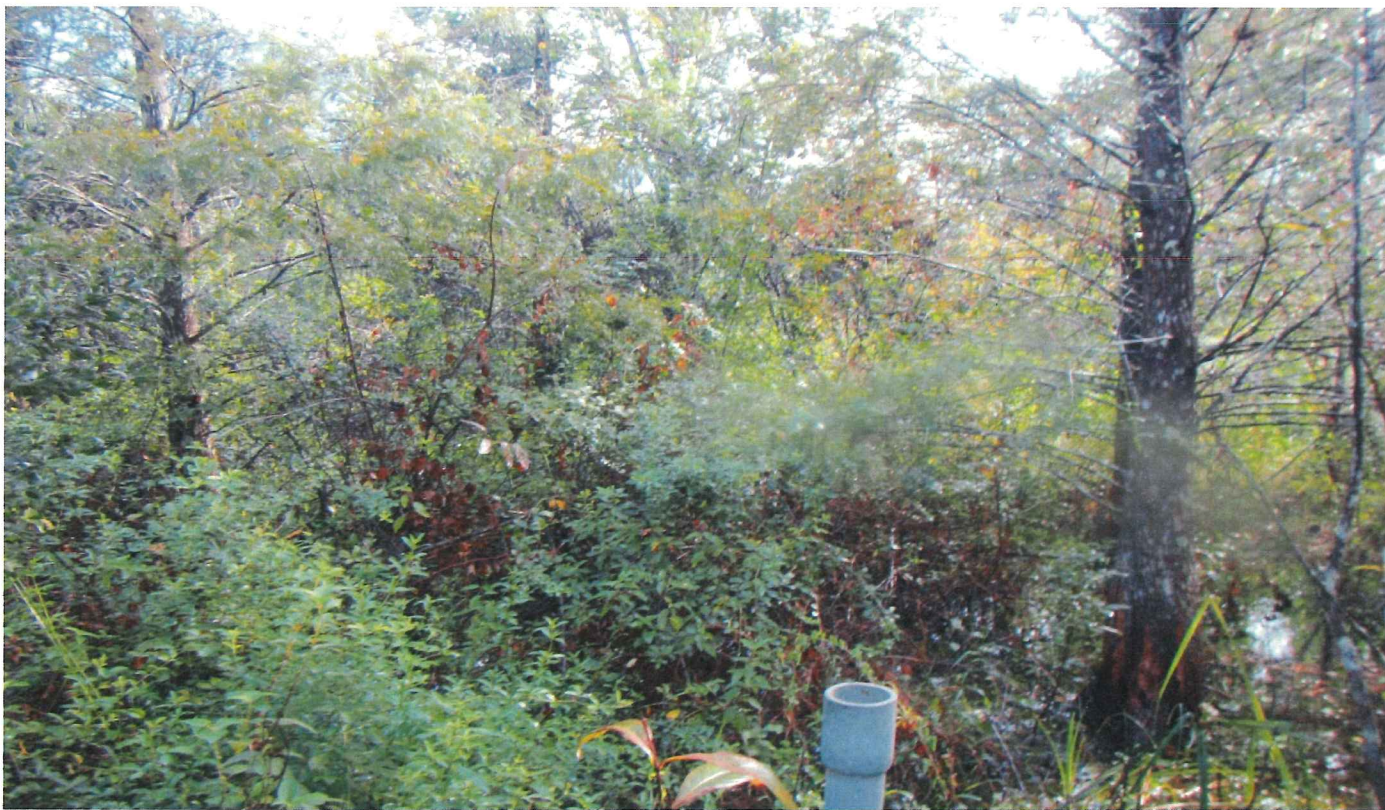
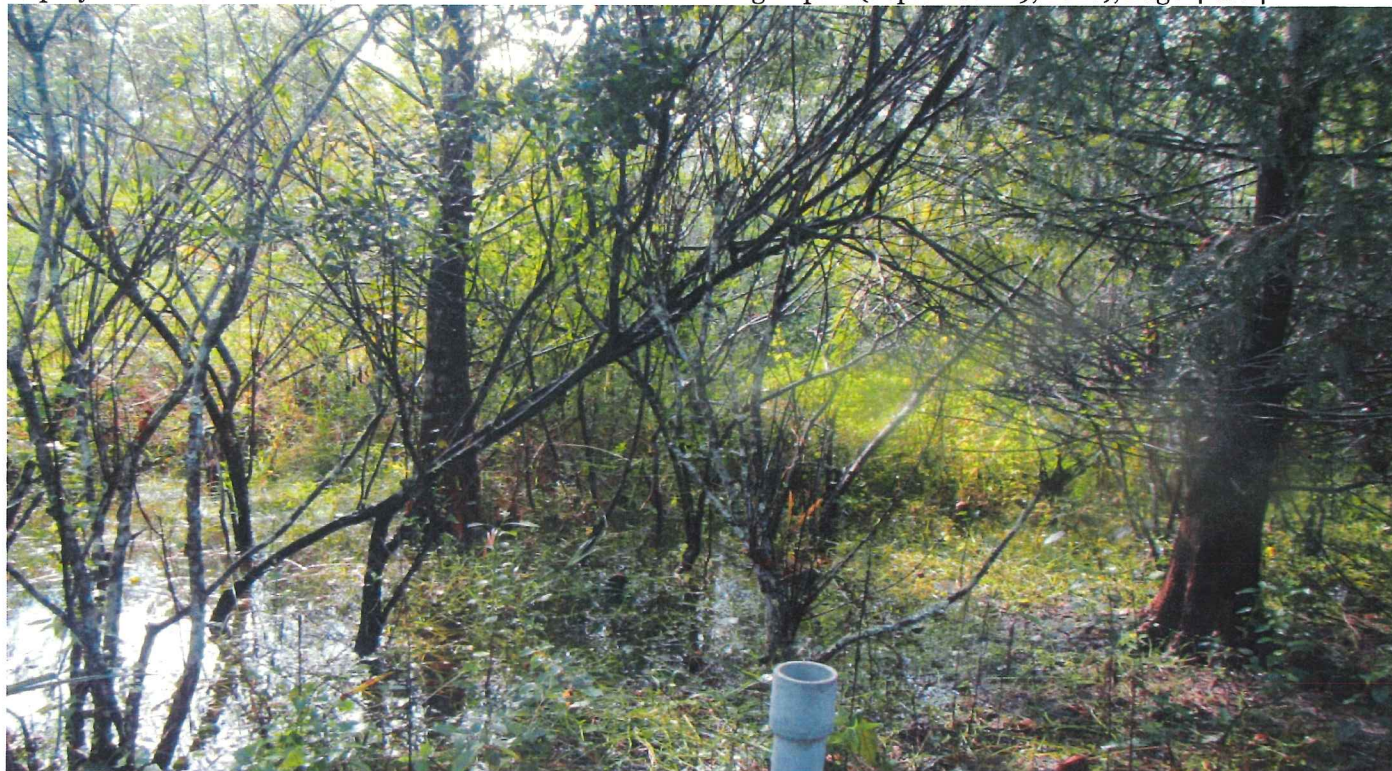
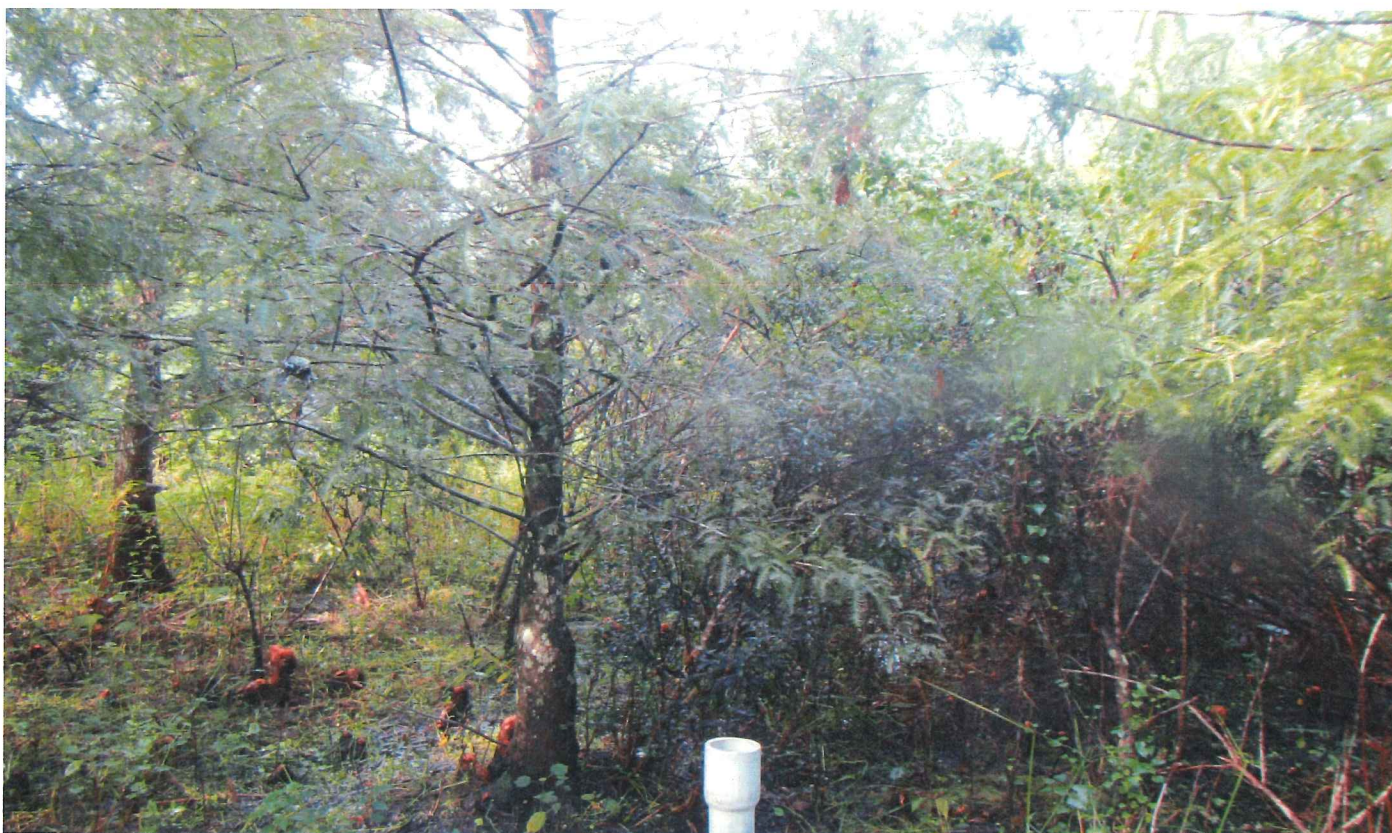
Transect #1 - Photo Station #1A – Looking North

Transect #1 - Photo Station #1A – Looking East

Transect #1 - Photo Station #1A – Looking South

Transect #1 - Photo Station #1A – Looking West

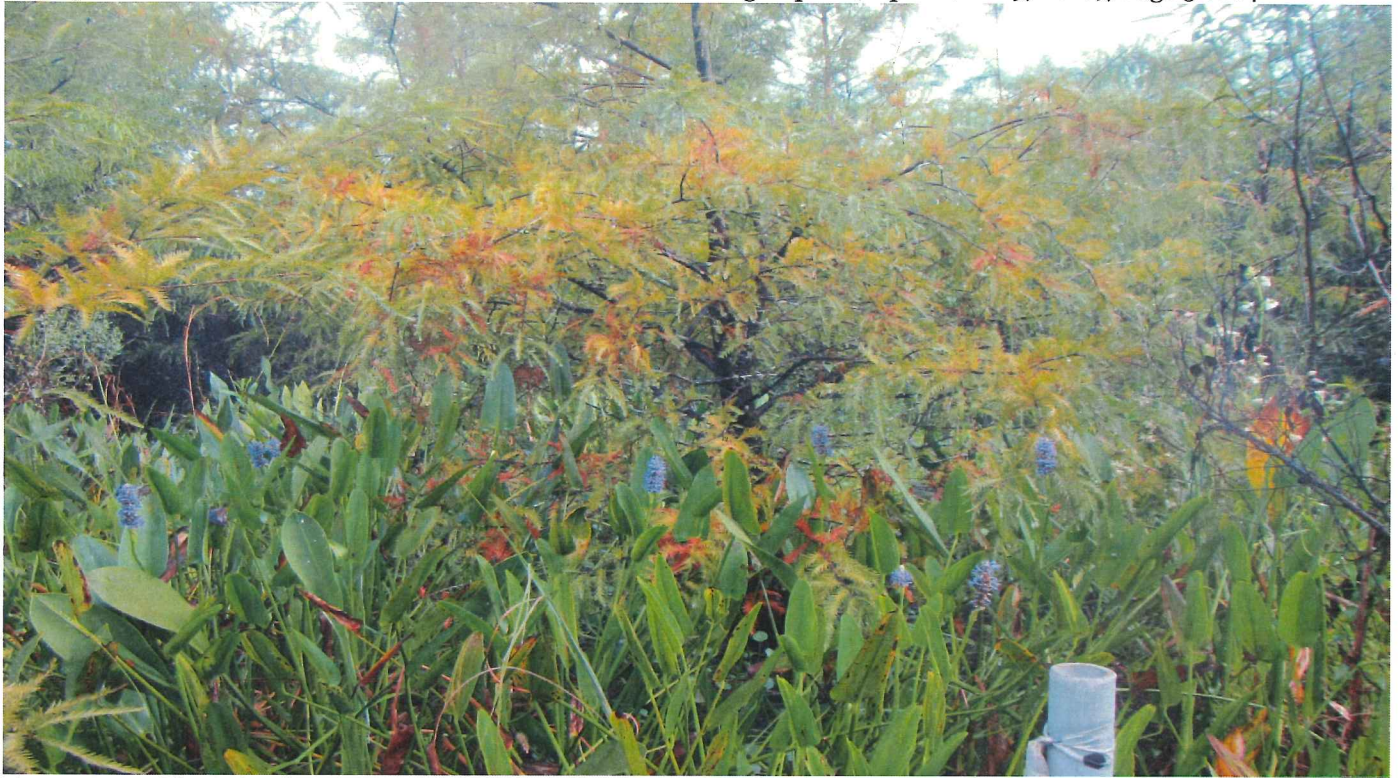
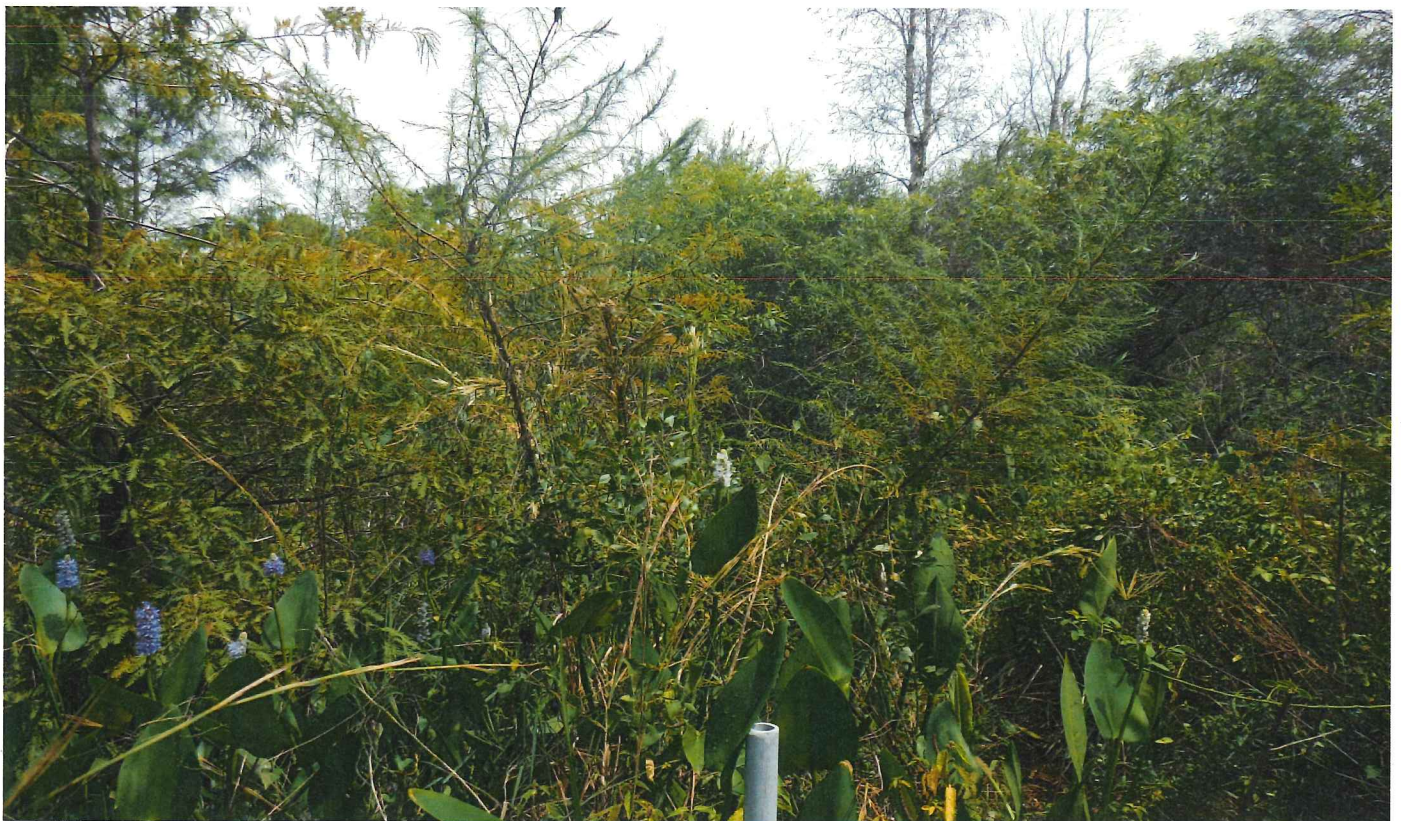
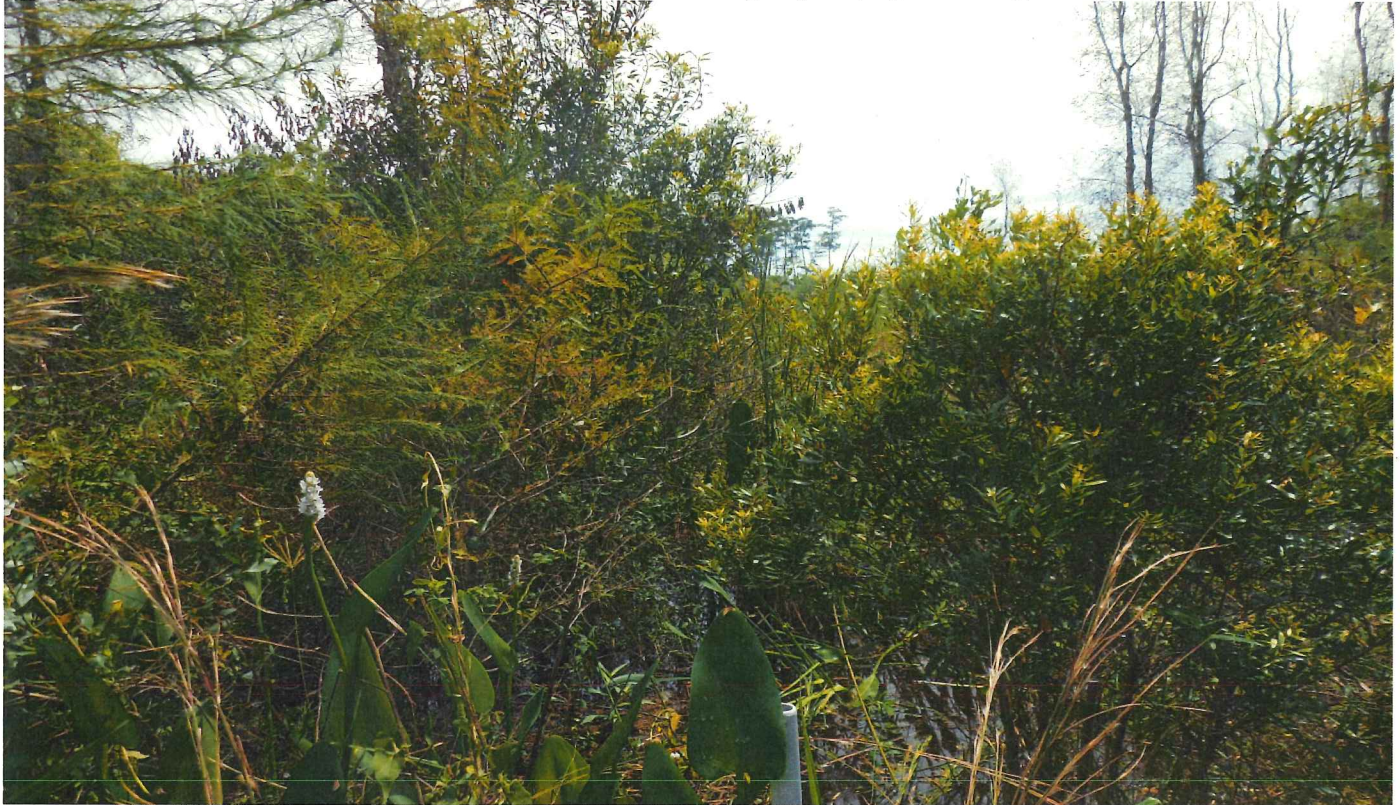
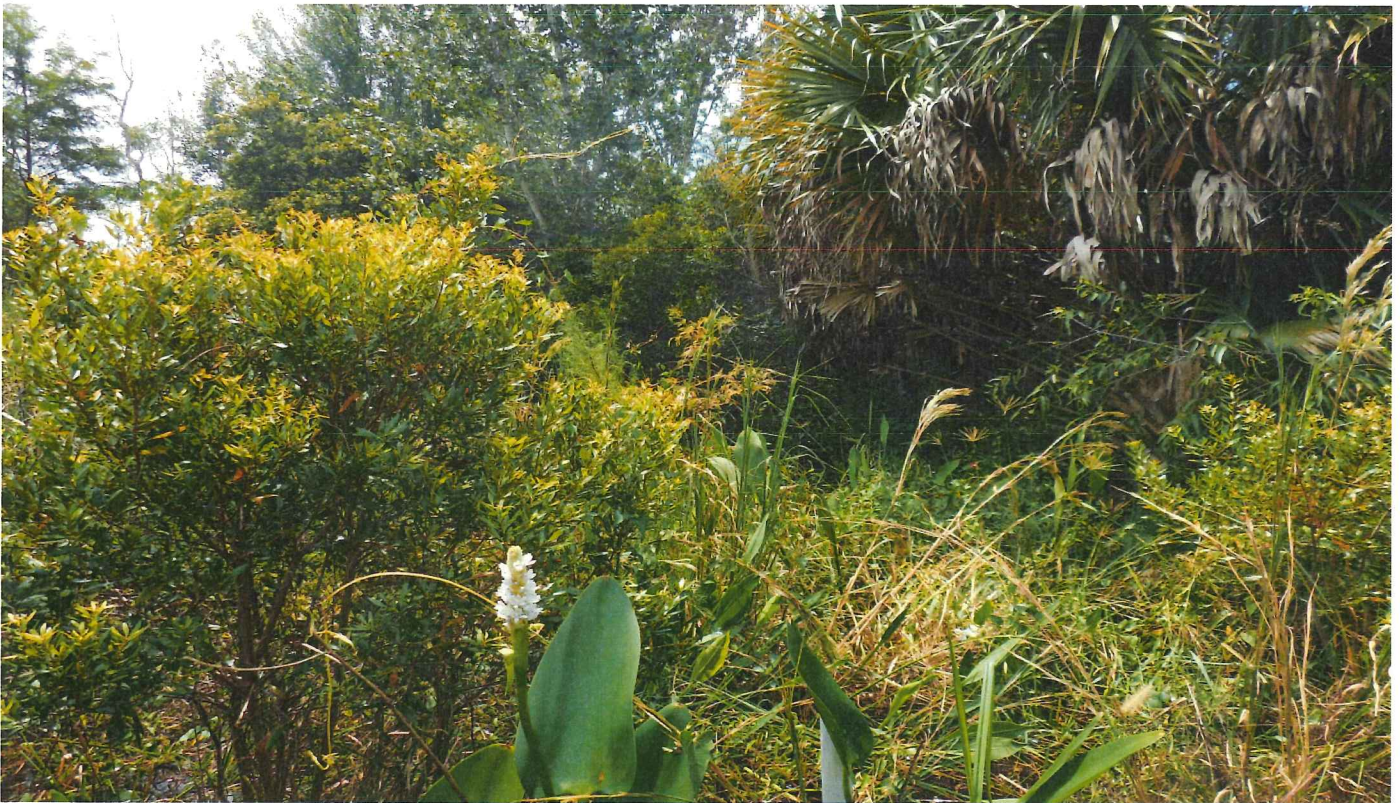
(*Blechnum serrulatum*), Florida tassel flower (*Emilia fosbergii*), maidencane (*Panicum hemitomon*), smartweed (*Polygonum punctatum*), pickerelweed (*Pontedaria cordata*), arrowhead (*Sagittaria lancifolia*), blue flag iris (*Iris virginica*), and fireflag (*Thalia geniculata*). Planted species observed at Photo Station #1A (new in the 2014 report) and Photo Station #2 included primarily cypress, red maple, buttonbush and most of the herbaceous wetland species listed above. Water levels were much higher this year than previously observed. The soils were saturated at Photo Station #1. Photo station #1A had approximately 10" of standing water present and there was approximately 18" of standing water at Photo station #2.

Transect #1 - Photo Station #2 – Looking North

Transect #1 - Photo Station #2 – Looking East

Transect #1 - Photo Station #2 – Looking South

Transect #1 - Photo Station #2 – Looking West

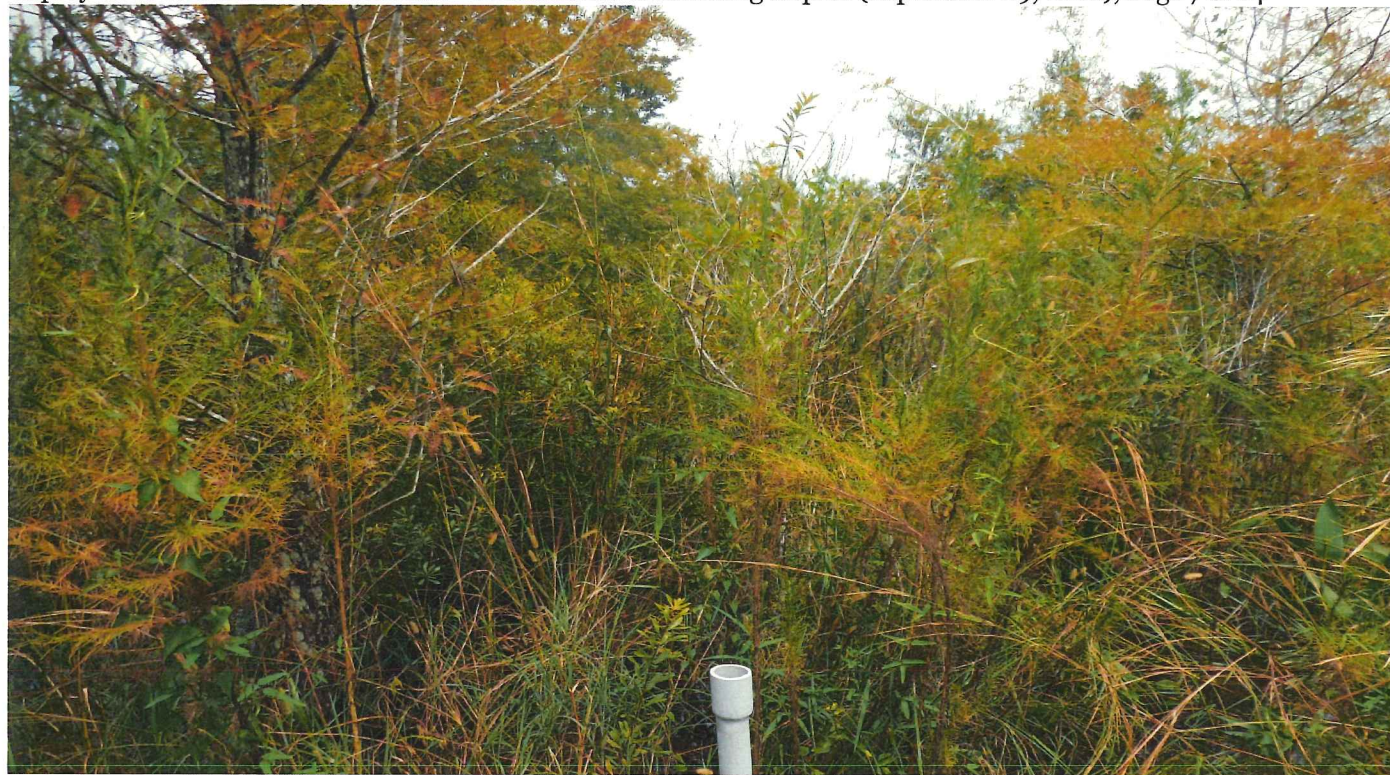
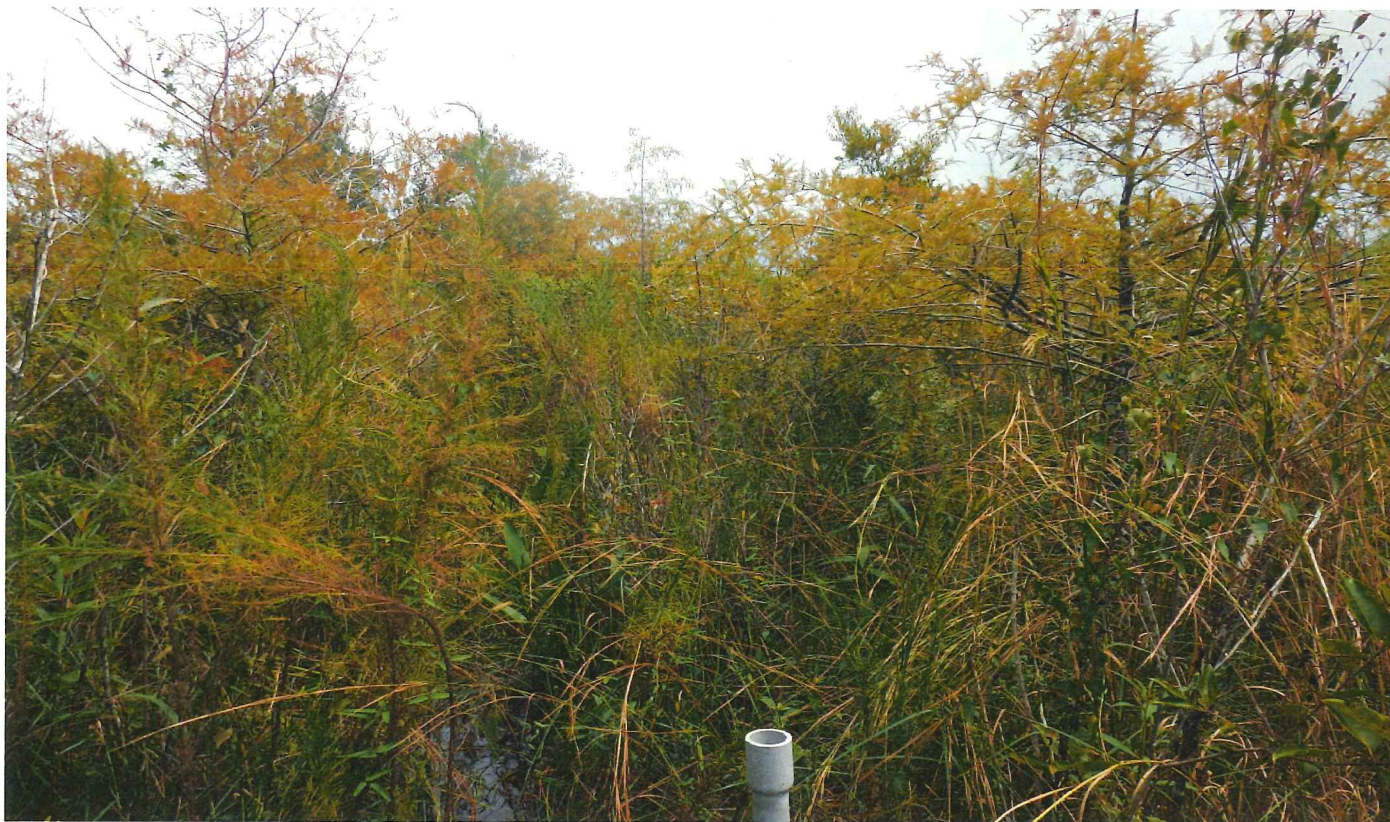
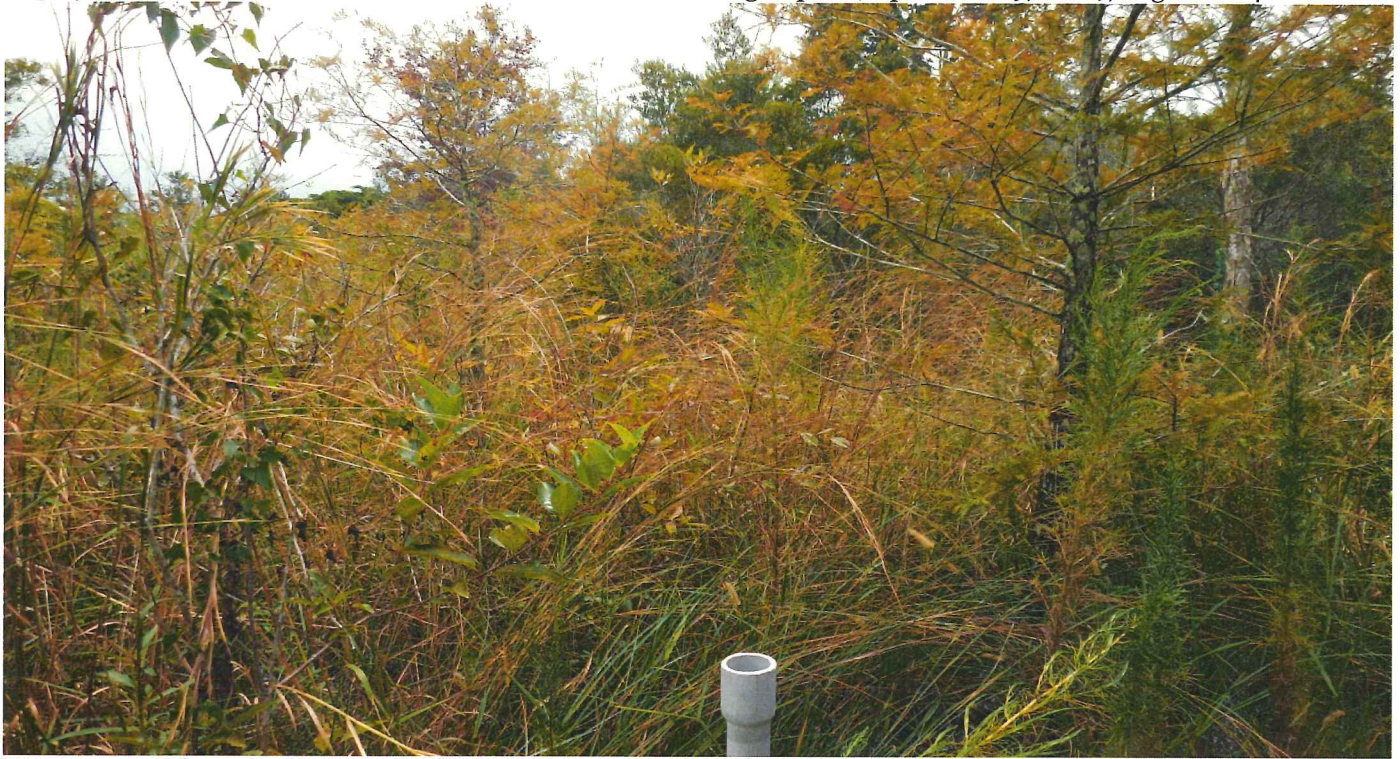
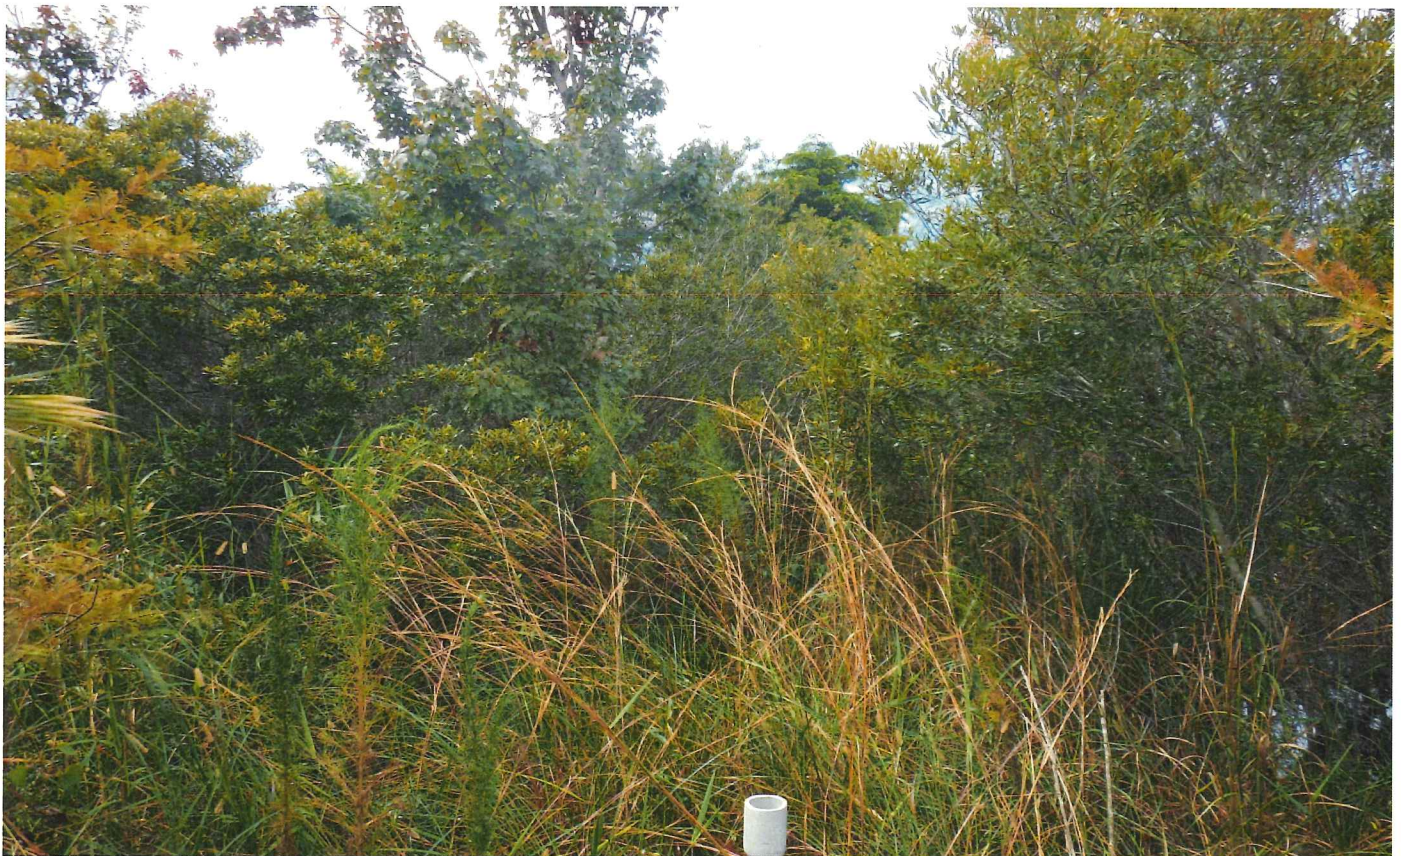
Water depth varied along this transect from 10" near Photo Station #3 to 33" near Photo Station #4. There was standing water along the entire length of this monitoring transect at the time of inspection. Numerous fish species as well as crayfish and apple snails (eggs) were also observed throughout the wetland habitat.

Transect #2 - Photo Station #3 – Looking North

Transect #2 - Photo Station #3 – Looking East

Transect #2 - Photo Station #3 – Looking South

Transect #2 - Photo Station #3 – Looking West

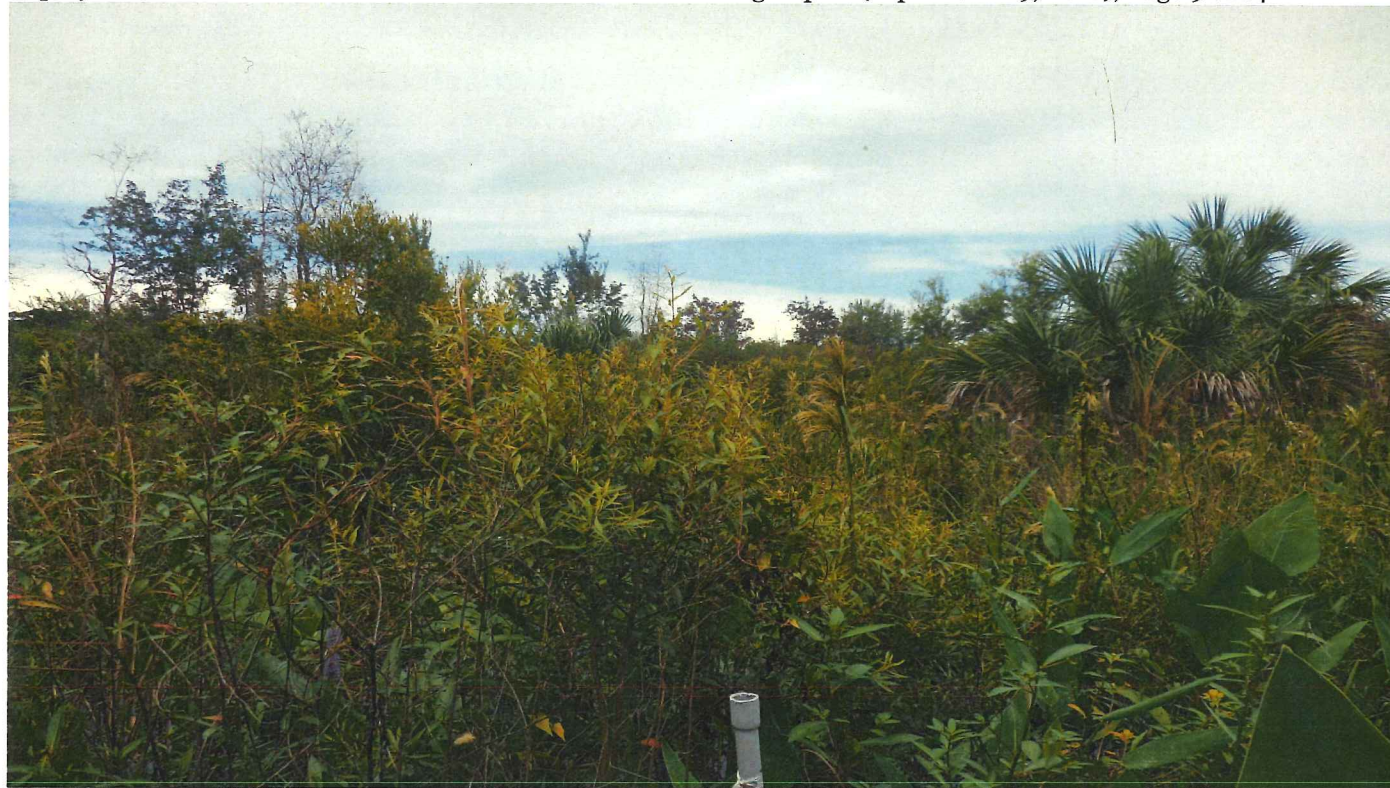
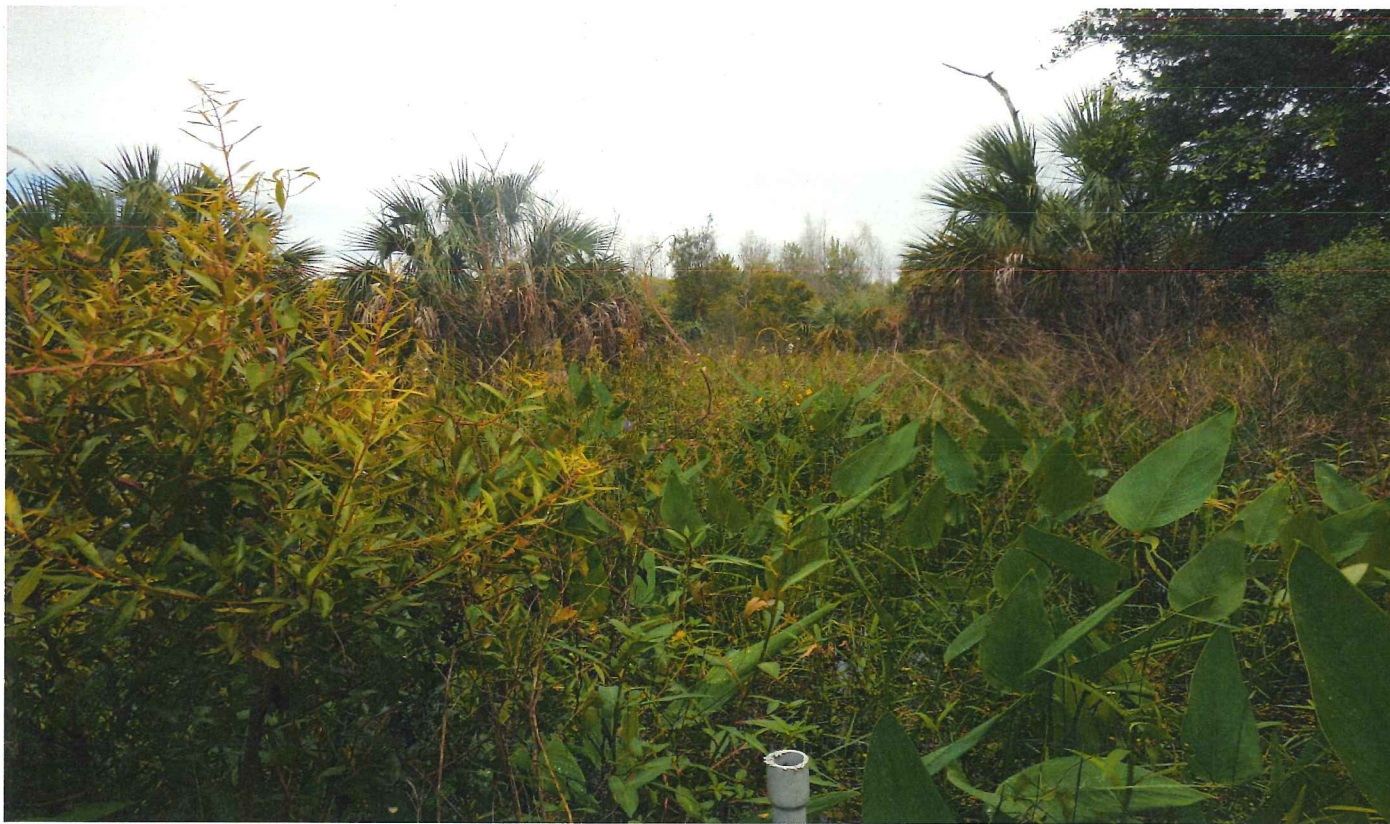
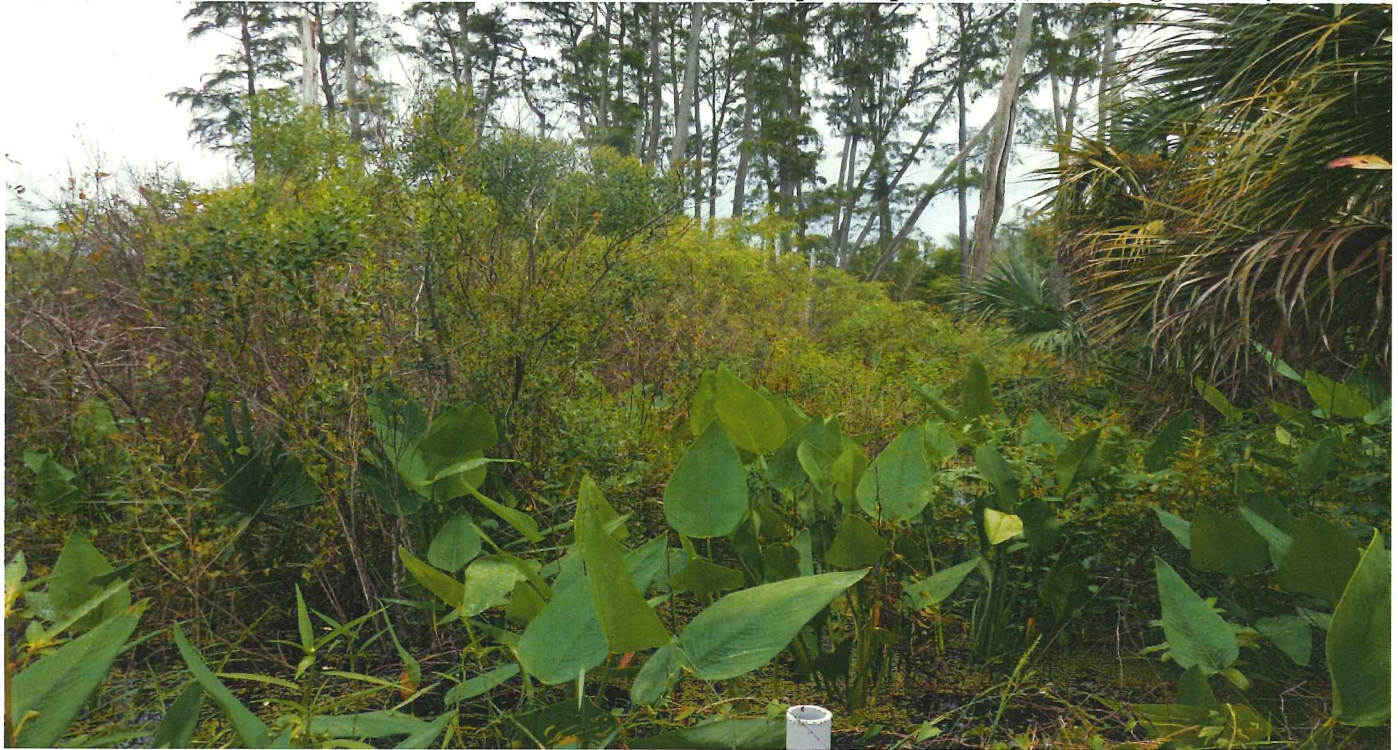
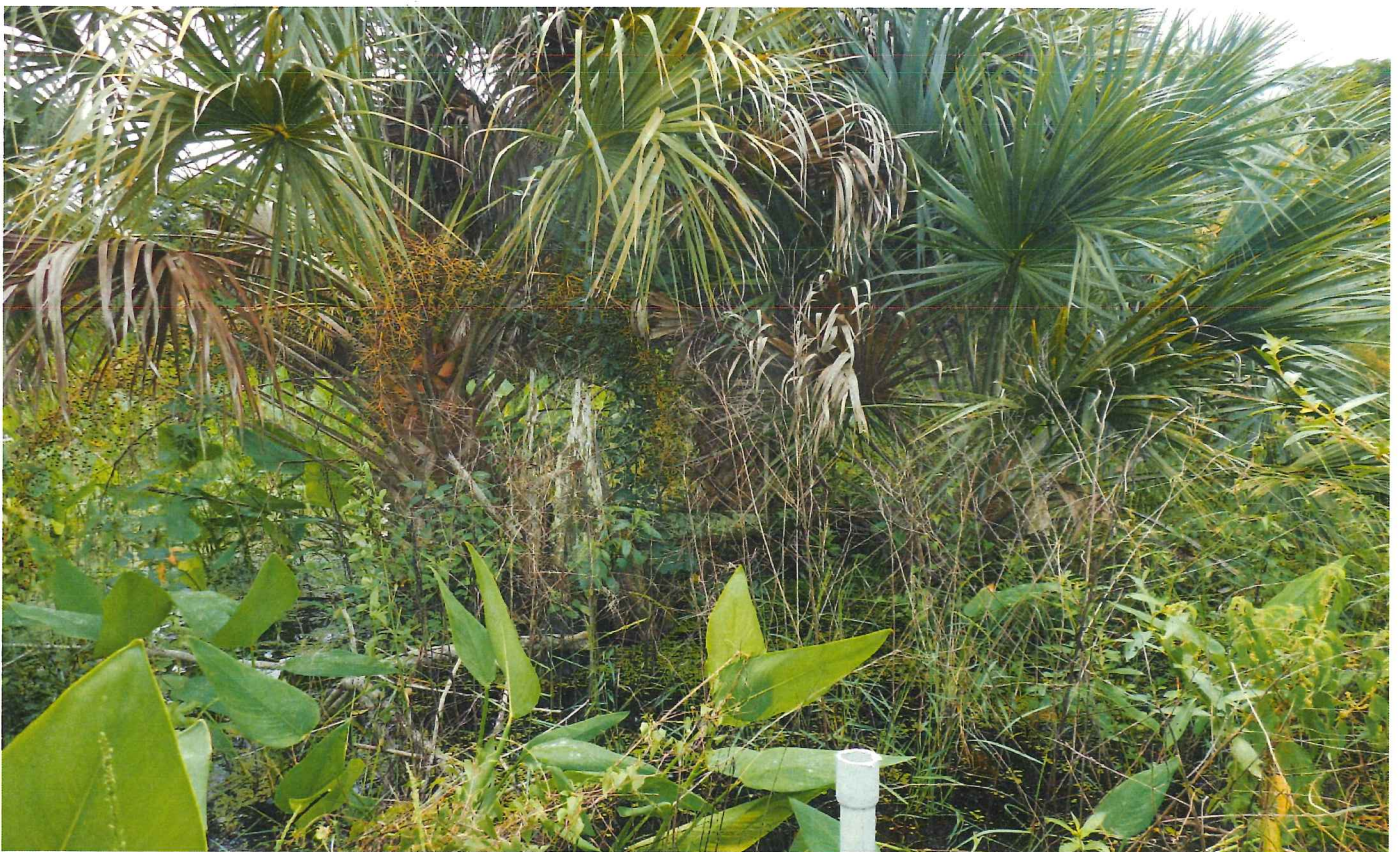
Transect #2 - Photo Station #4 – Looking North

Transect #2 - Photo Station #4 – Looking East

Transect #2 - Photo Station #4 – Looking South

Transect #2 - Photo Station #4 – Looking West
