**OSPREY COVE FIFTH ANNUAL  
MONITORING REPORT**

SFWMD Permit #36-04886-P

Lee County D.O. #2004-00207

OCTOBER 2016

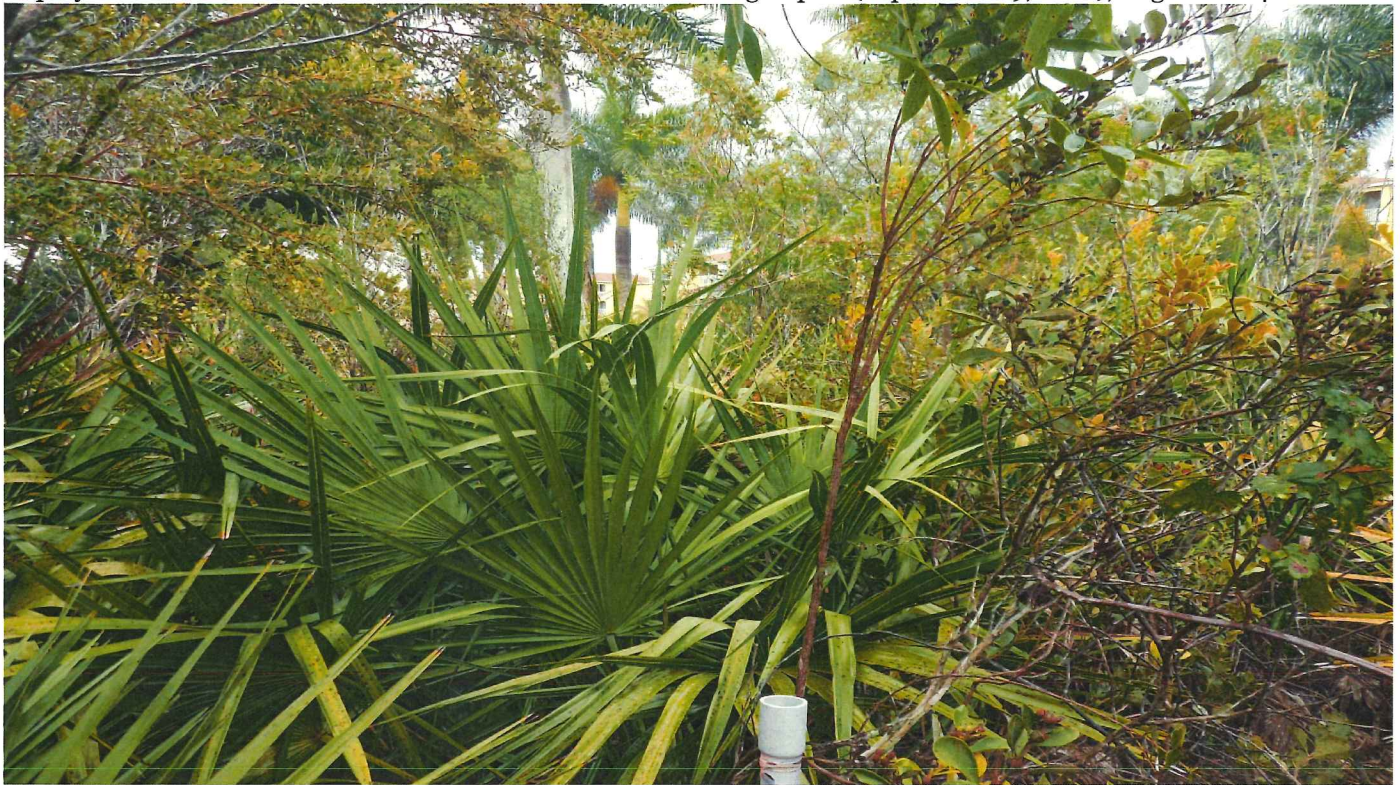
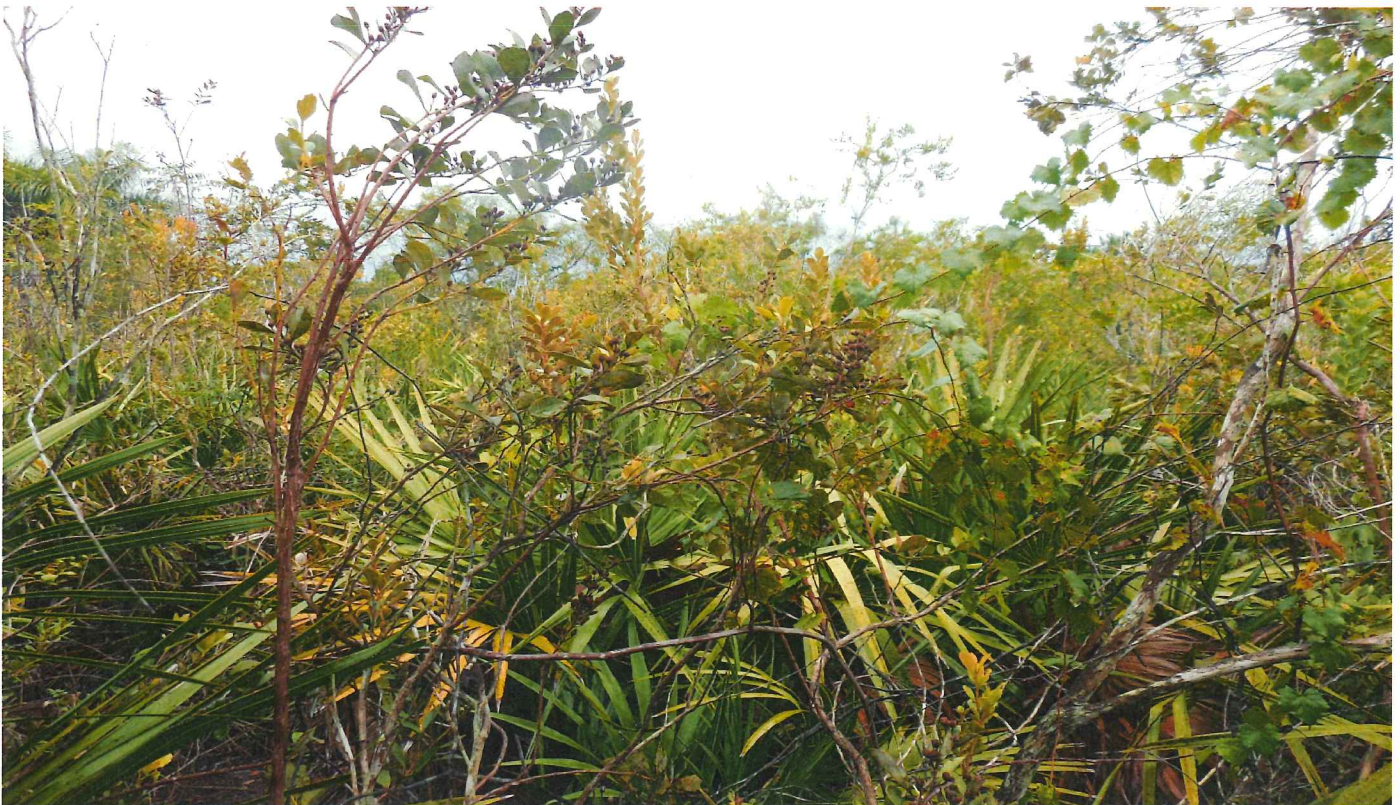
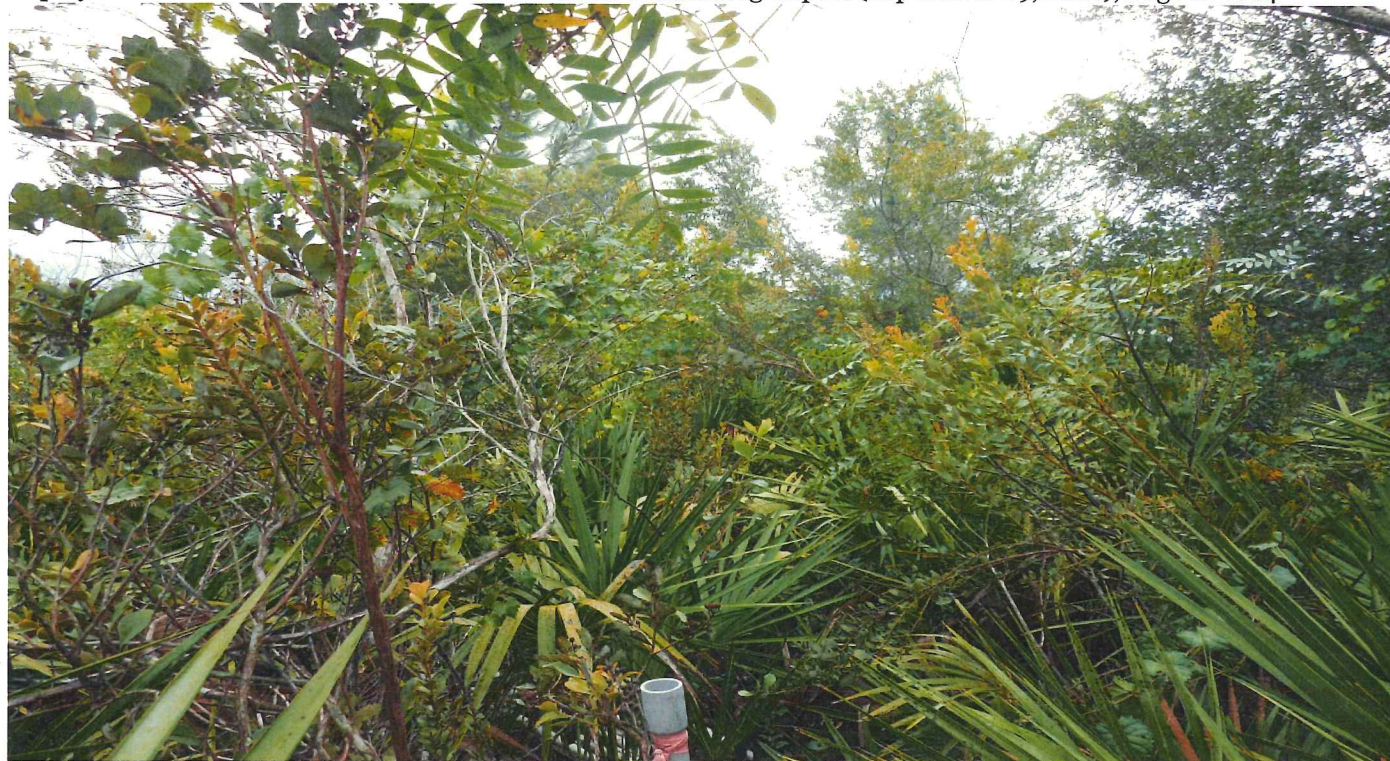
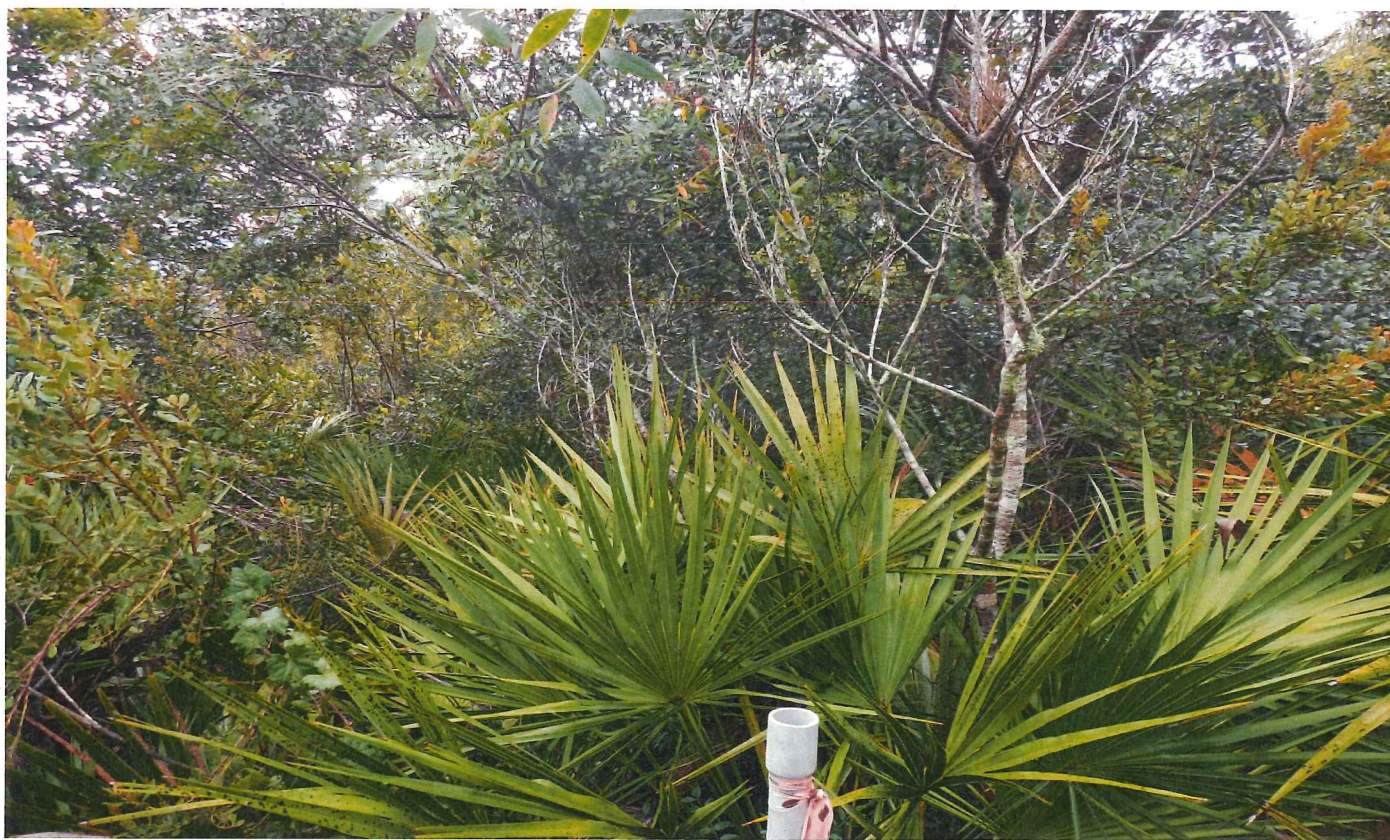
Transect #3 - Photo Station #5 – Looking North

Transect #3 - Photo Station #5 – Looking East

Transect #3 - Photo Station #5 – Looking South

Transect #3 - Photo Station #5 – Looking West

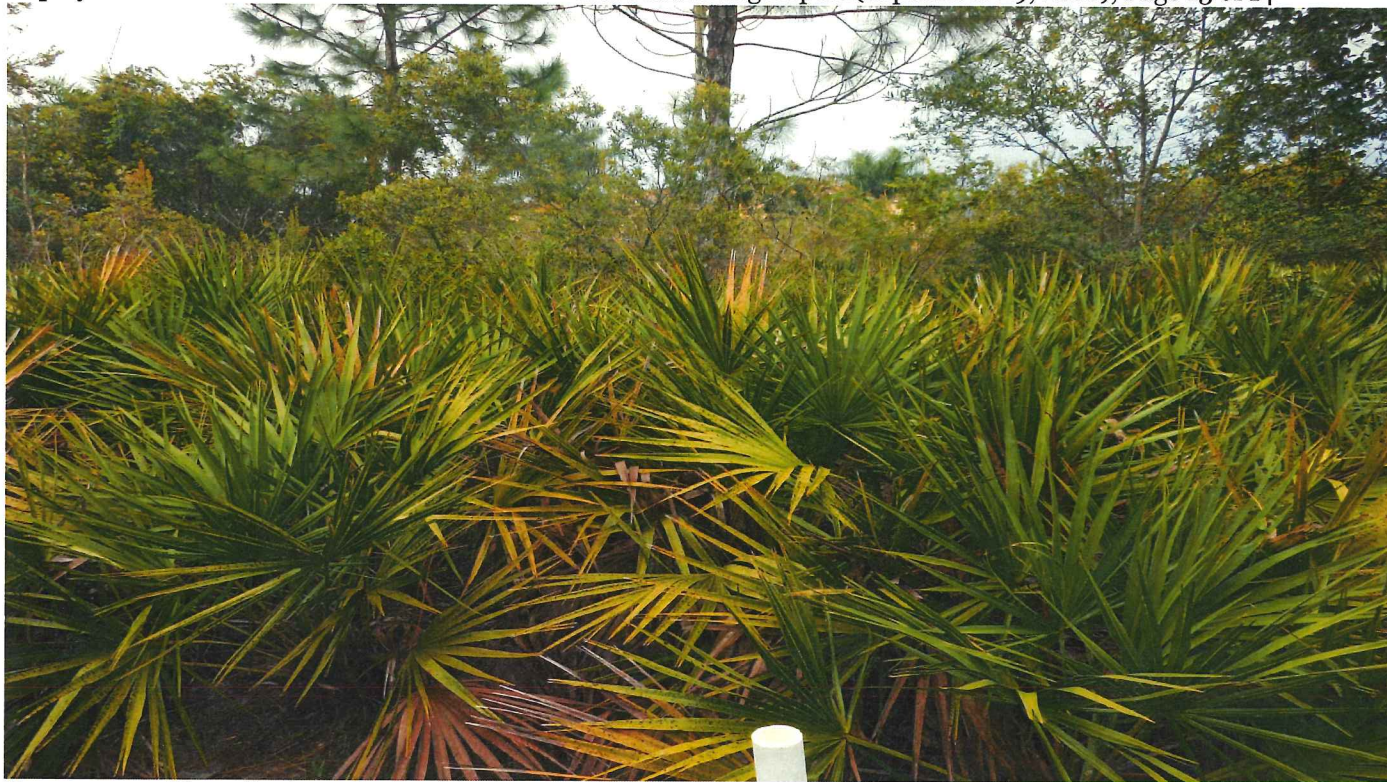
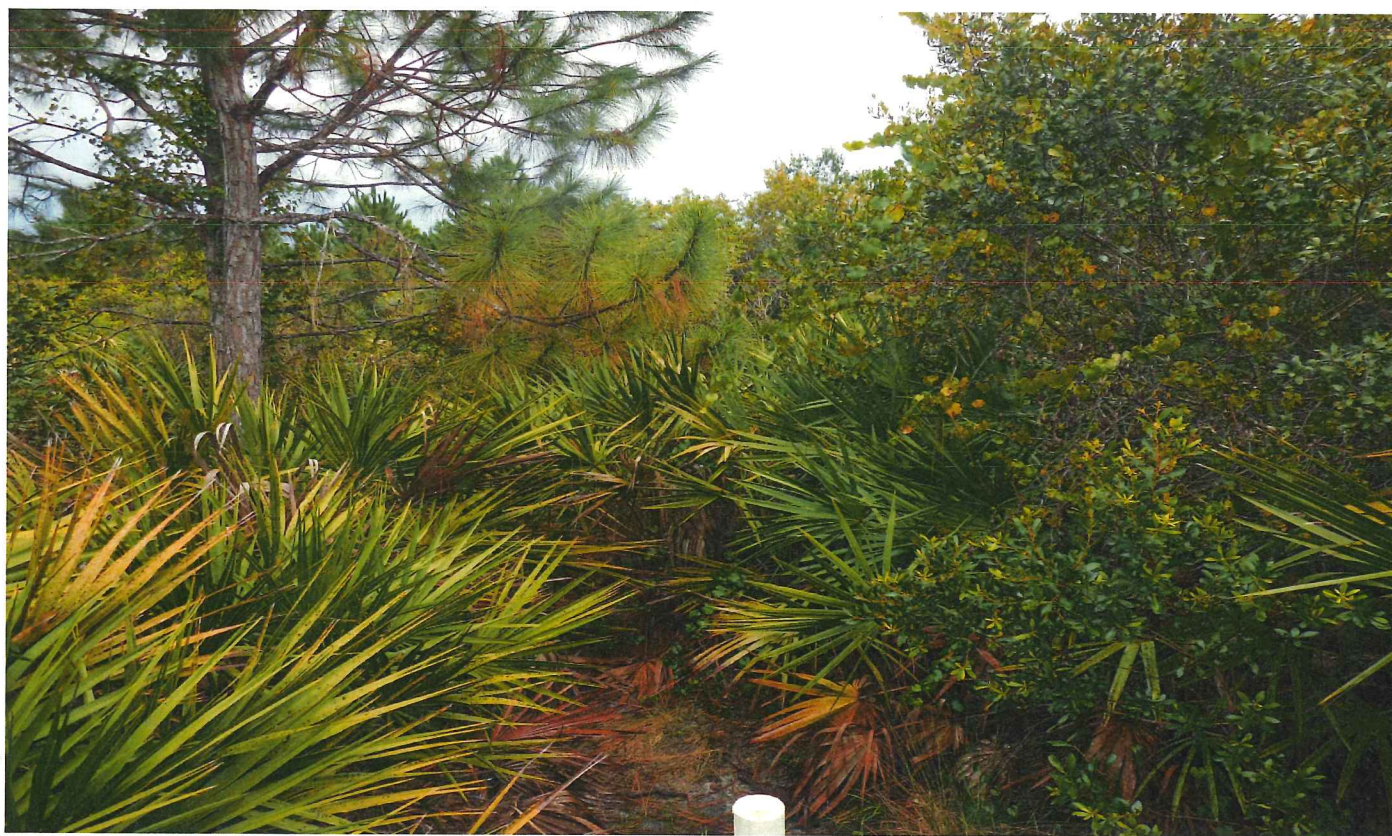
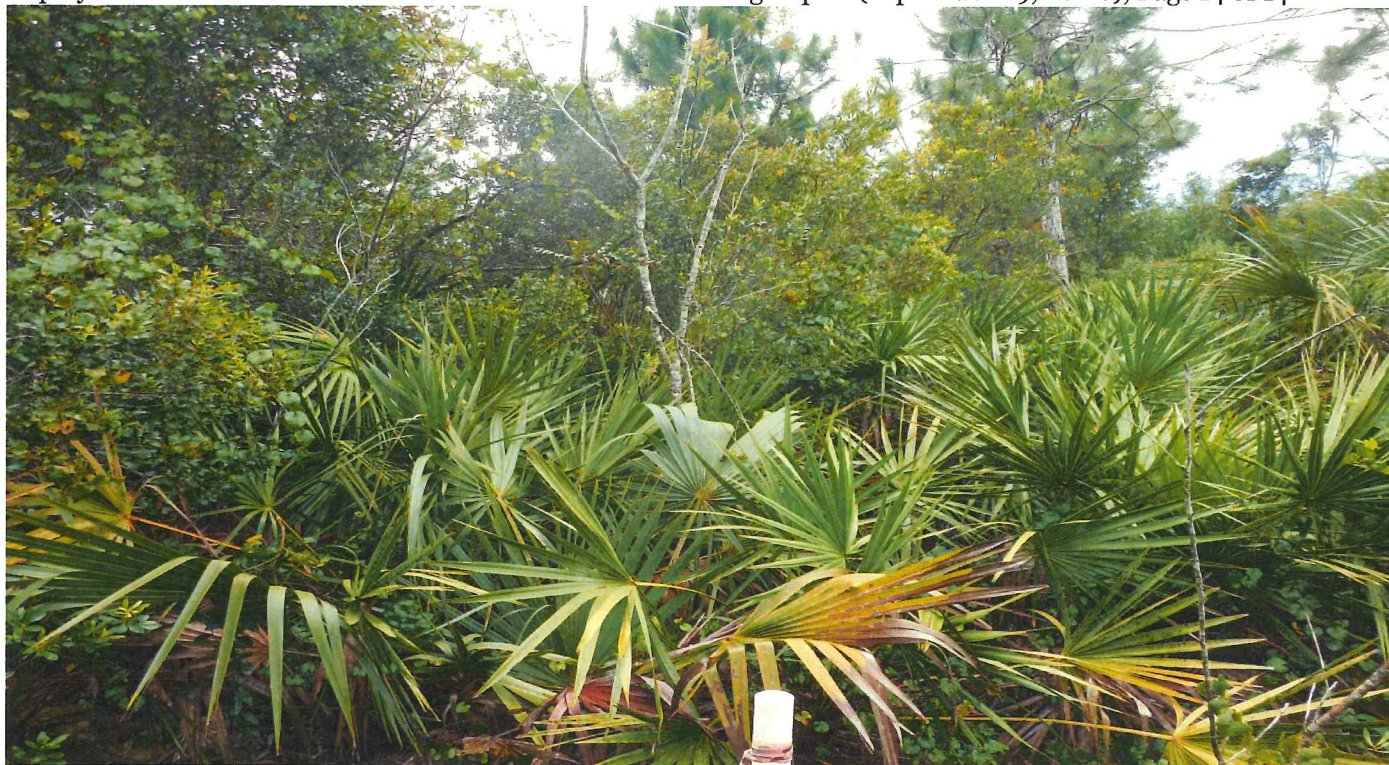
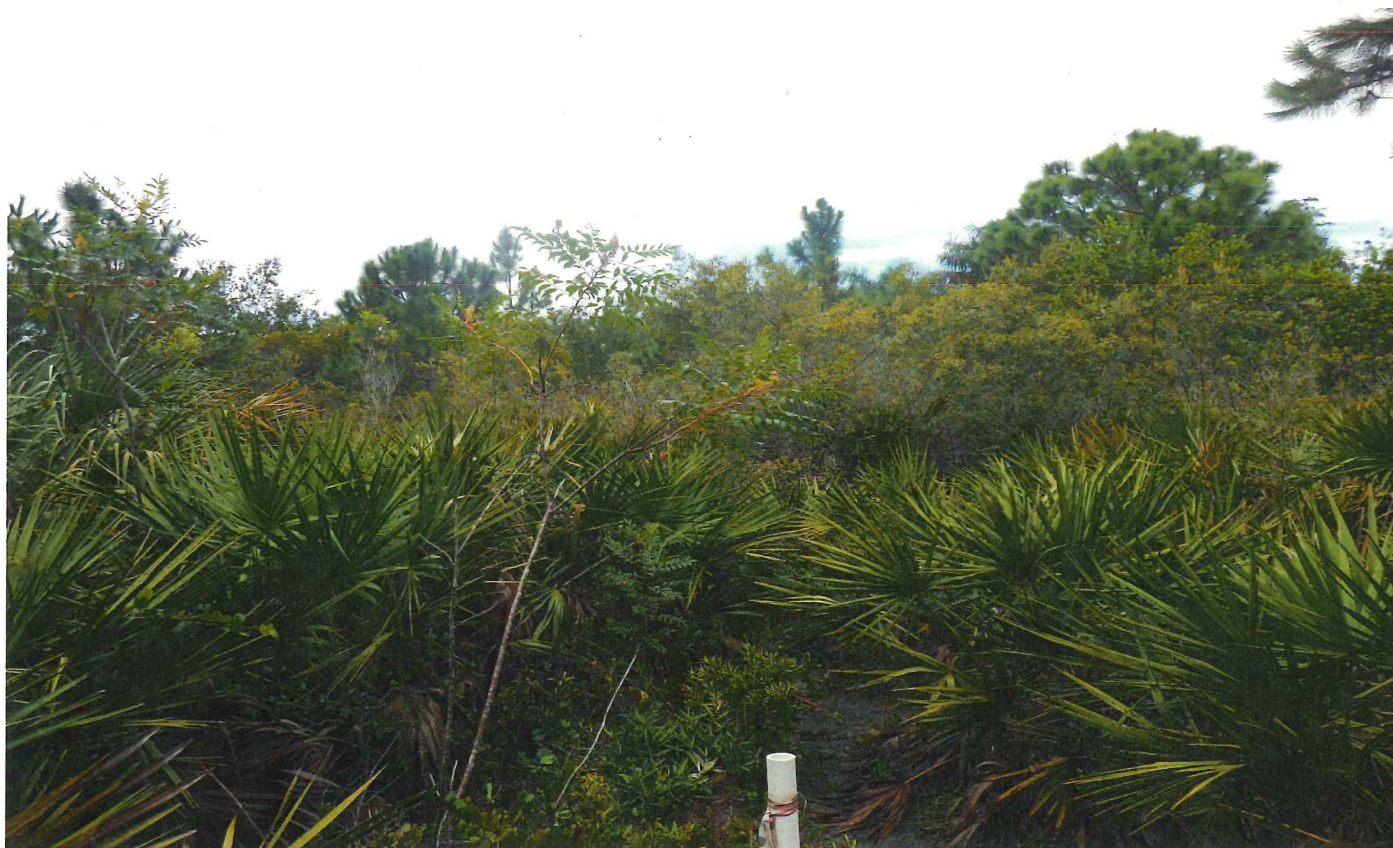
Transect #3 - Photo Station #6 – Looking North

Transect #3 - Photo Station #6 – Looking East

Transect #3 - Photo Station #6 – Looking South

Transect #3 - Photo Station #6 – Looking West

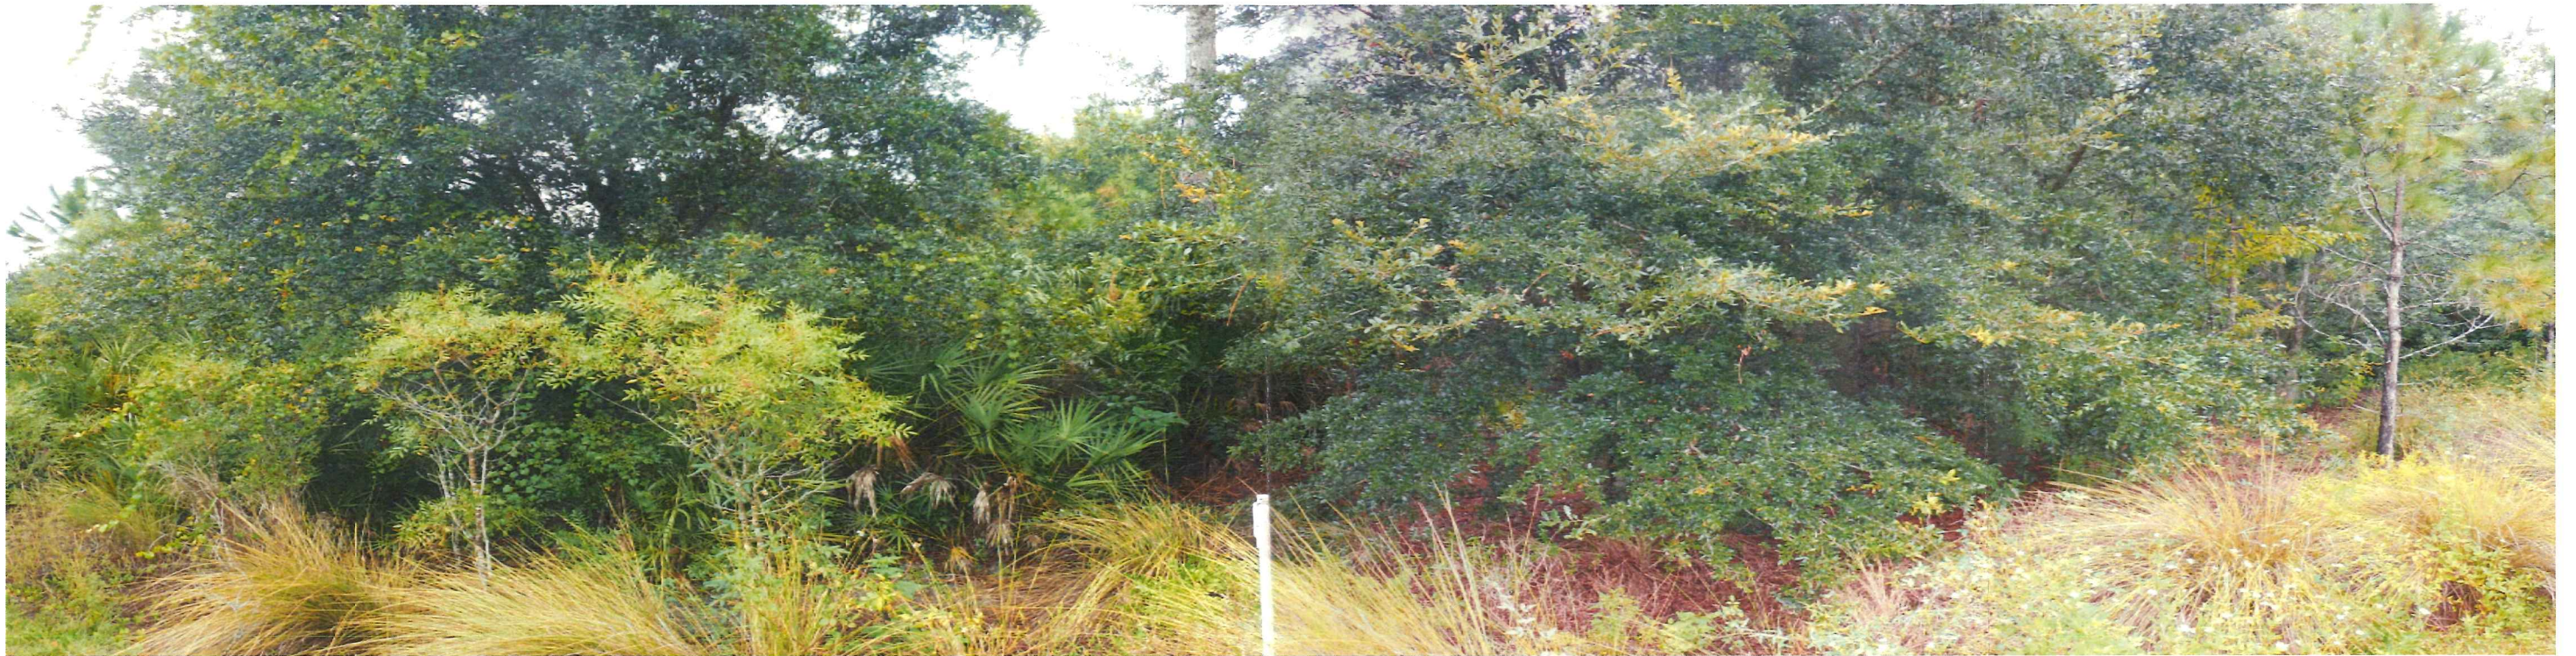
Indigenous Habitat Restoration Area A is located on the far eastern edge of the property in the southern corner abutting the railroad right-of-way. This indigenous habitat was replanted with slash pine, cabbage palm, live oak, dahoon holly, Carolina willow, and bald cypress as future canopy species. Wax myrtle, coco-plum, saltbush, and beautyberry were planted as shrubs for this habitat. Sand cordgrass, Gulf muhly grass, three-awn grass (*Aristida stricta*), red root, black-eyed Susan (*Rudbeckia hirta*), and beach dune sunflower (*Helianthus debilis*) were planted as the groundcover species throughout this general area. A significant number of the original plantings have survived and the plant species listed above are also represented in the areas where plantings were installed. The wax myrtle has already begun to seed and naturally spread throughout the general area. Saltbush has also increased in abundance throughout this indigenous area and within the adjacent upland preserve habitat. Native rusty lyonia and saw palmetto has naturally recruited into this general area. The groundcover in this area accounts for approximately 80% of the cover.

Photo Station #7 – Indigenous Area A - Looking West (New photo location from original reports)

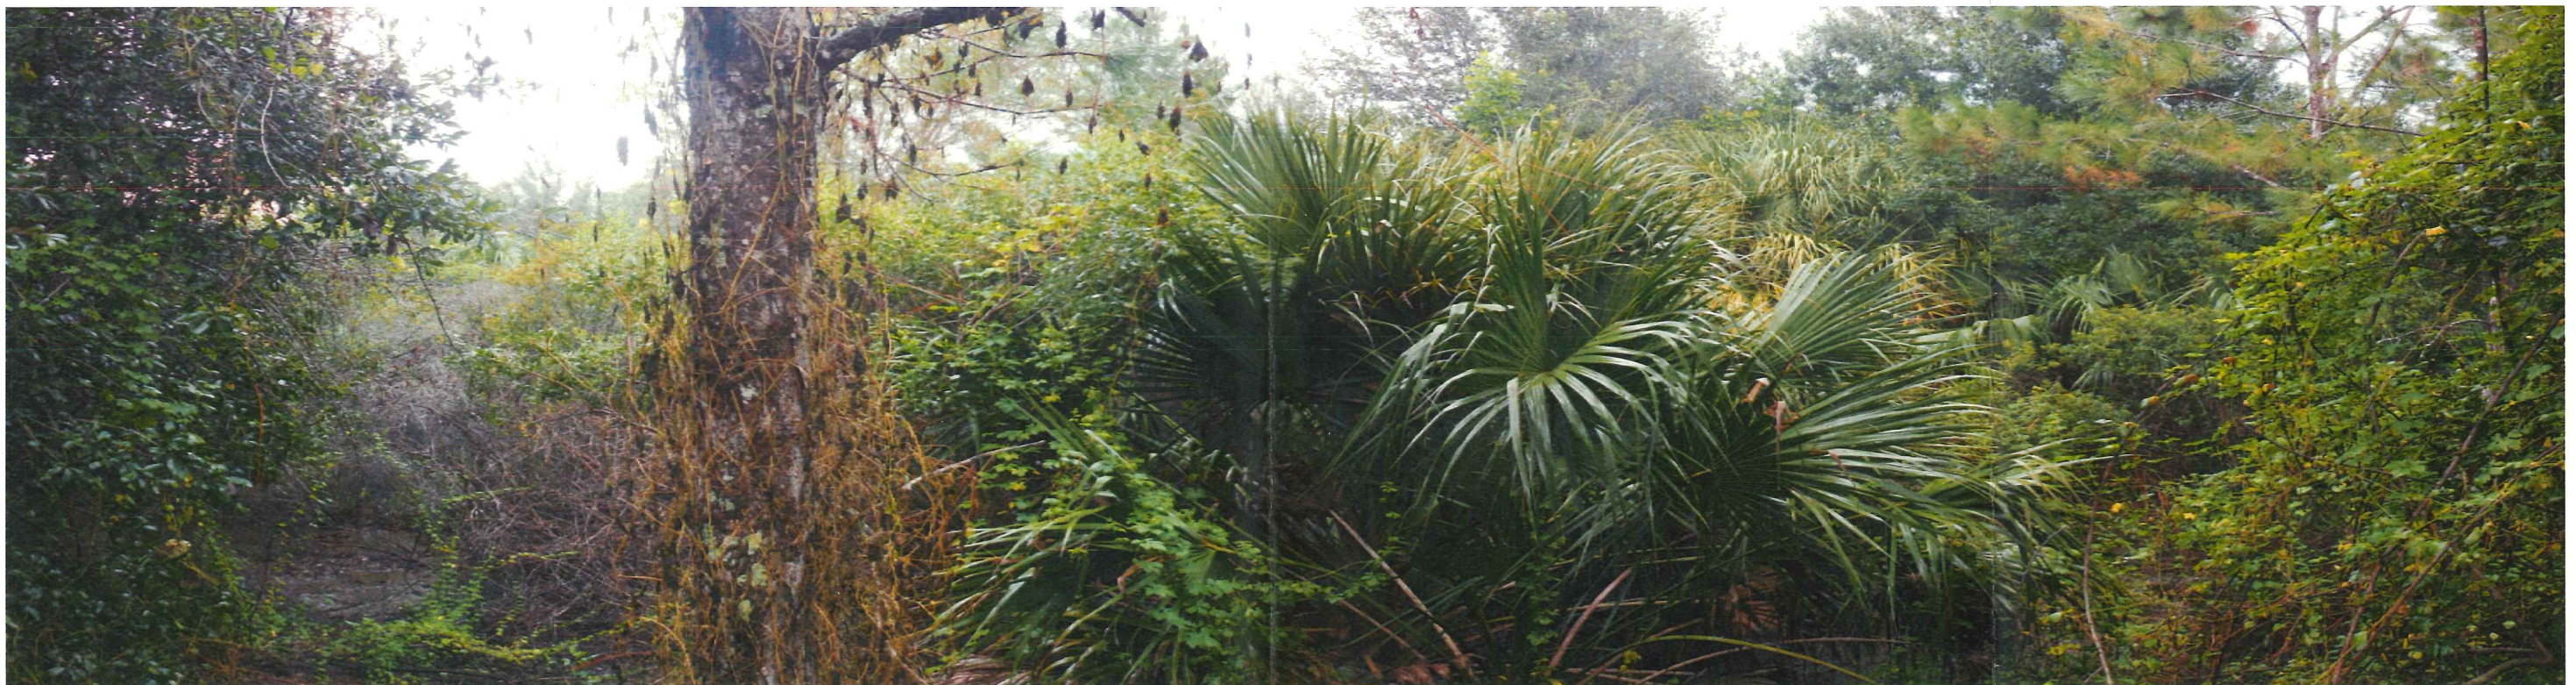
Indigenous Habitat Restoration Area B is an irregular shaped habitat located south of a parking lot in the southeastern corner of the development. The eastern edge of this preserve abuts the railroad right-of-way that forms the eastern property line. This area was planted with slash pine, cabbage palm, dahoon holly, and live oak as the canopy species. Saltbush, wax myrtle, beautyberry, and saw palmetto were the planted shrub species. Groundcover species planted included sand cordgrass, three-awn grass, Gulf muhly grass, and swamp fern. Naturally recruited groundcover species include begger-tick, broomsedge (*Andropogon virginicus*), and carpetweed (*Mollugo verticillata*).

Photo Station #8 – Indigenous Area B – Looking East

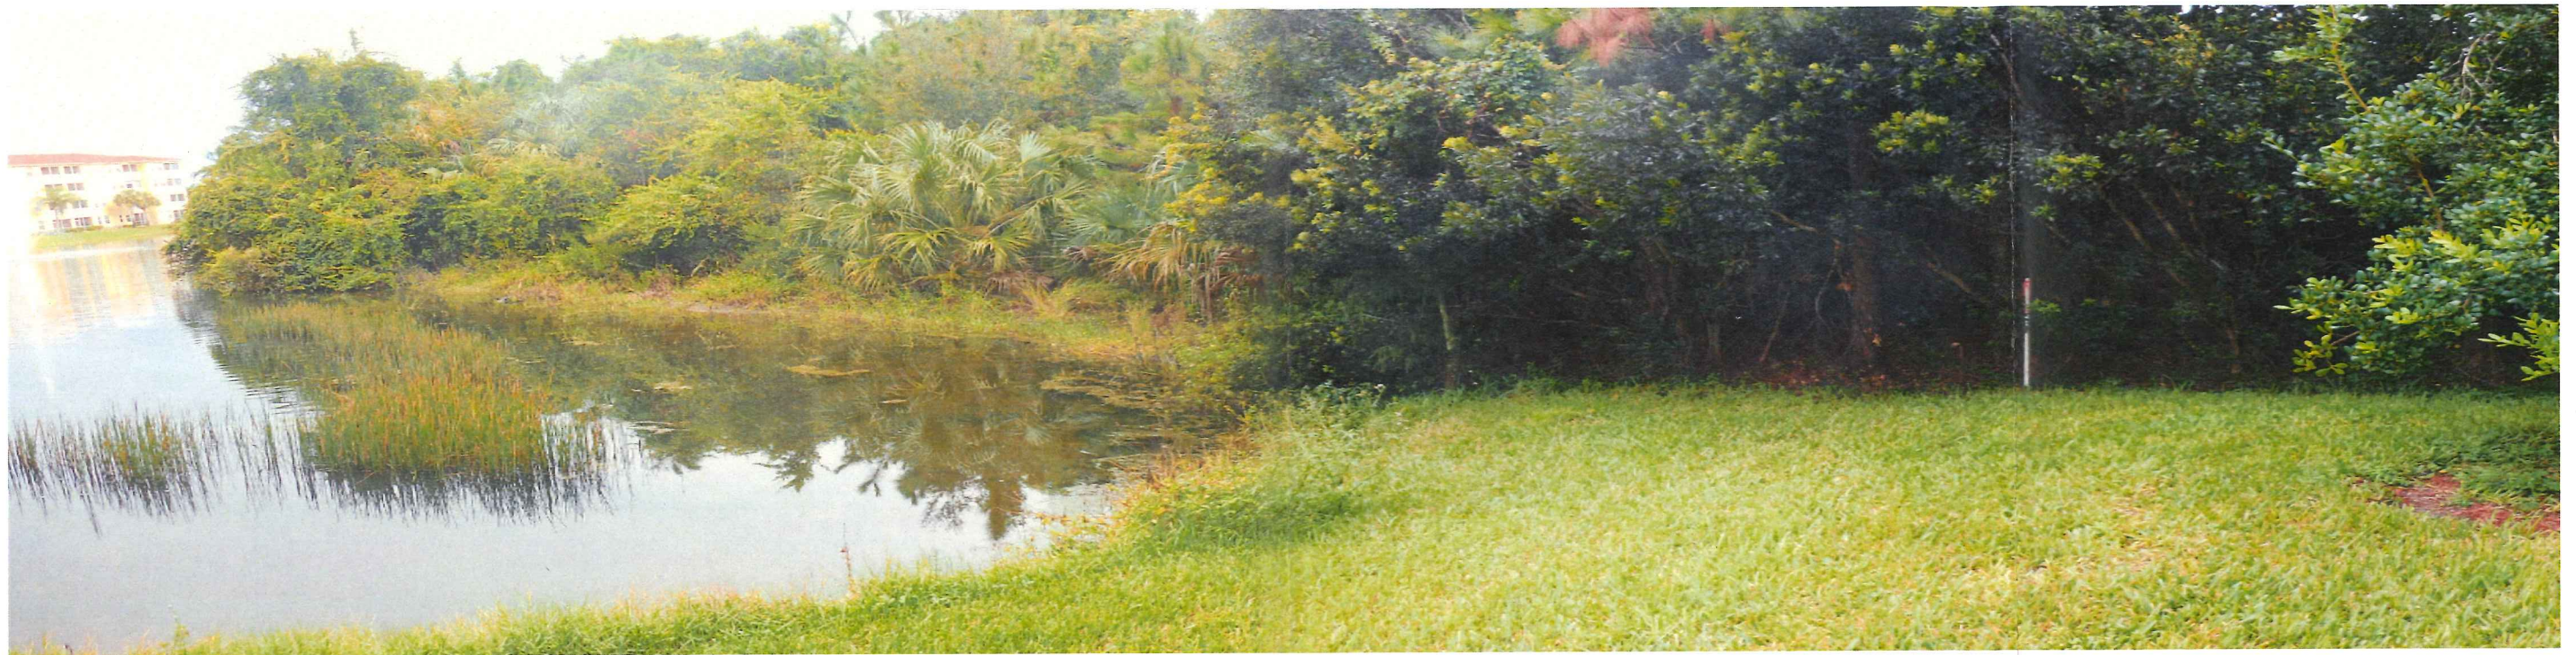
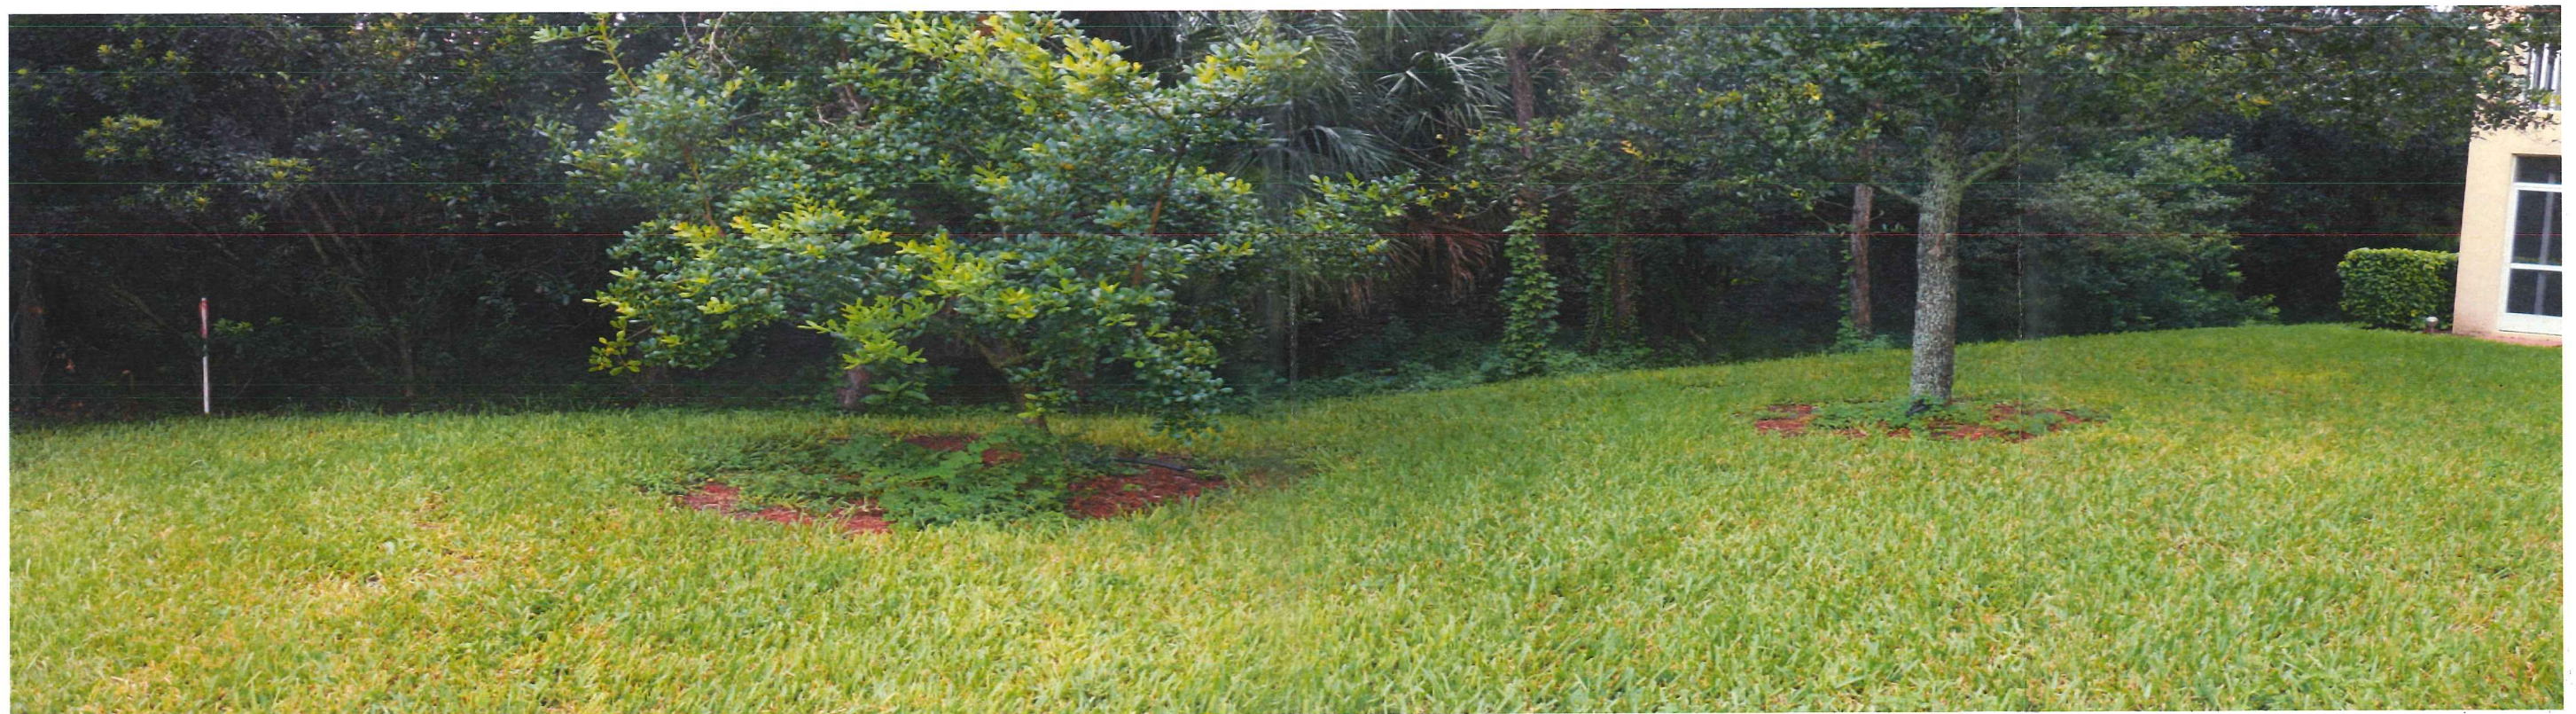
This linear indigenous area is located west of the surface water management pond behind the southernmost building within the development. Area C lies between the pond and the large wetland preserve. Slash pine, live oak, dahoon holly, cabbage palm, and seagrape (*Coccoloba uvifera*) comprised the canopy plantings in this indigenous habitat. Myrsine (*Rapanea punctata*), wax myrtle, saw palmetto, and beautyberry were the shrub plantings originally installed throughout this habitat. Gulf muhly grass, beach dune sunflower, railroad vine (*Ipomoea pes-carpe*), three-awn grass, and sand cordgrass were the herbaceous plantings installed in this area. A dominance of the planted material has survived and is thriving. The area is densely vegetated and very little open ground remains except under the dense tree canopy that has formed in this habitat.

Photo Station #9 – Indigenous Area C - Looking Southwest

Photo Station #9 – Indigenous Area C - Looking Northwest

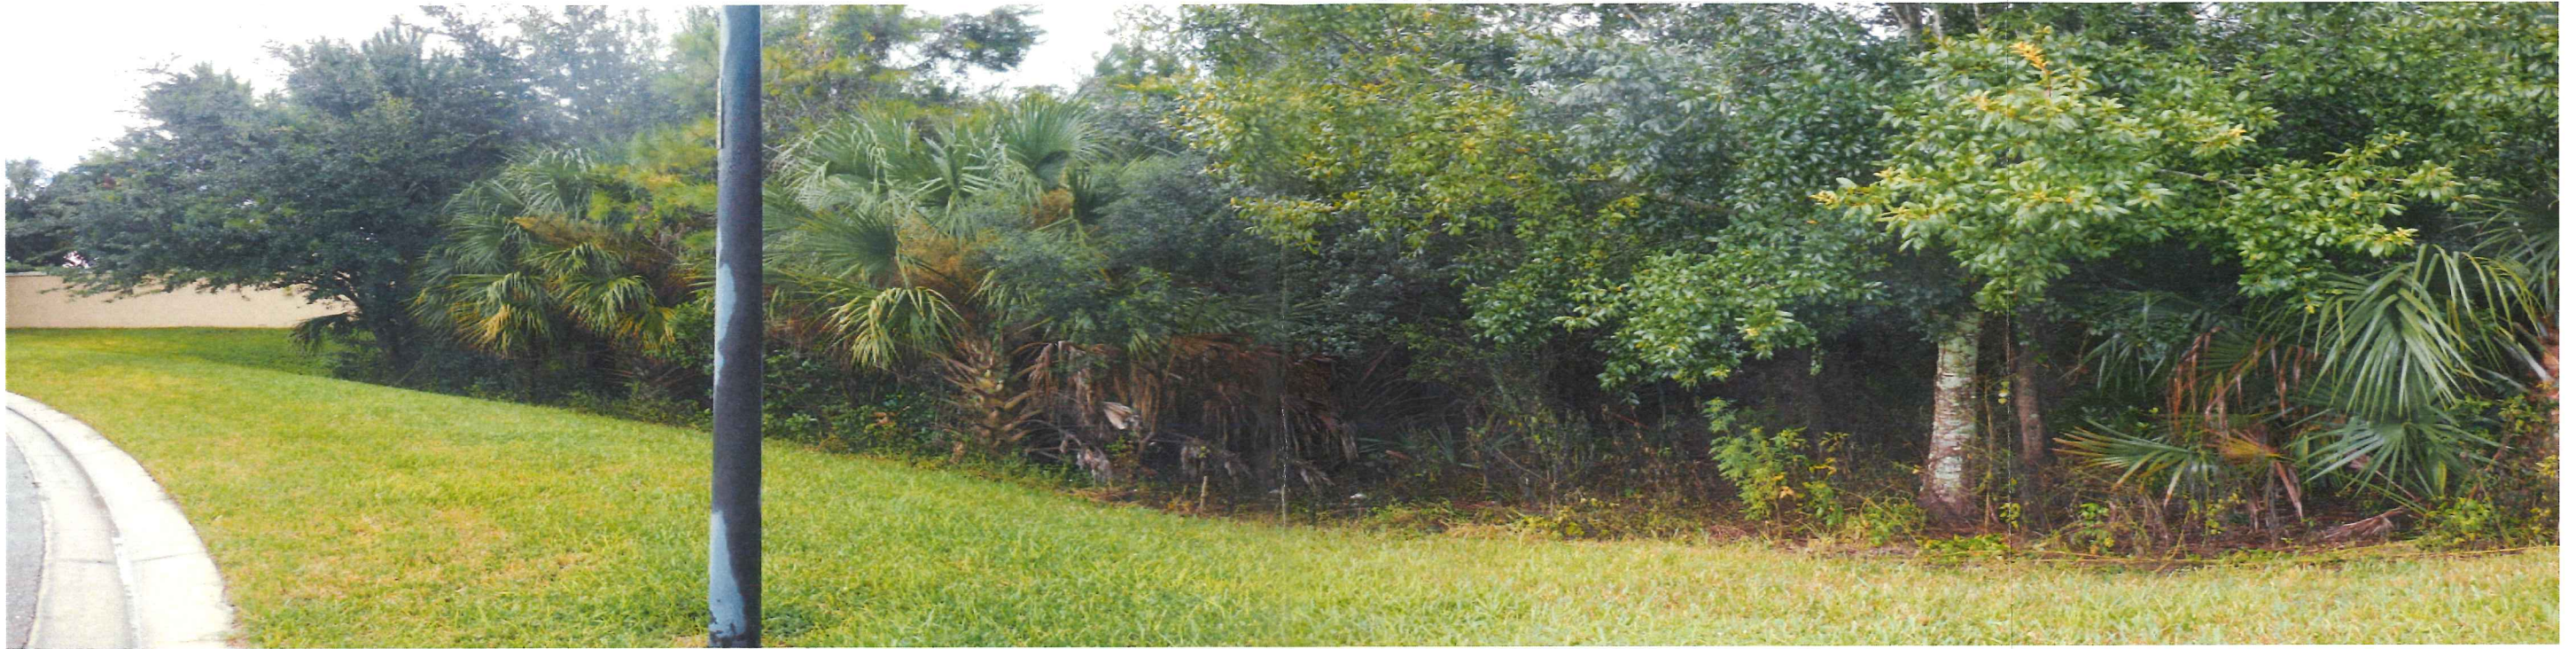
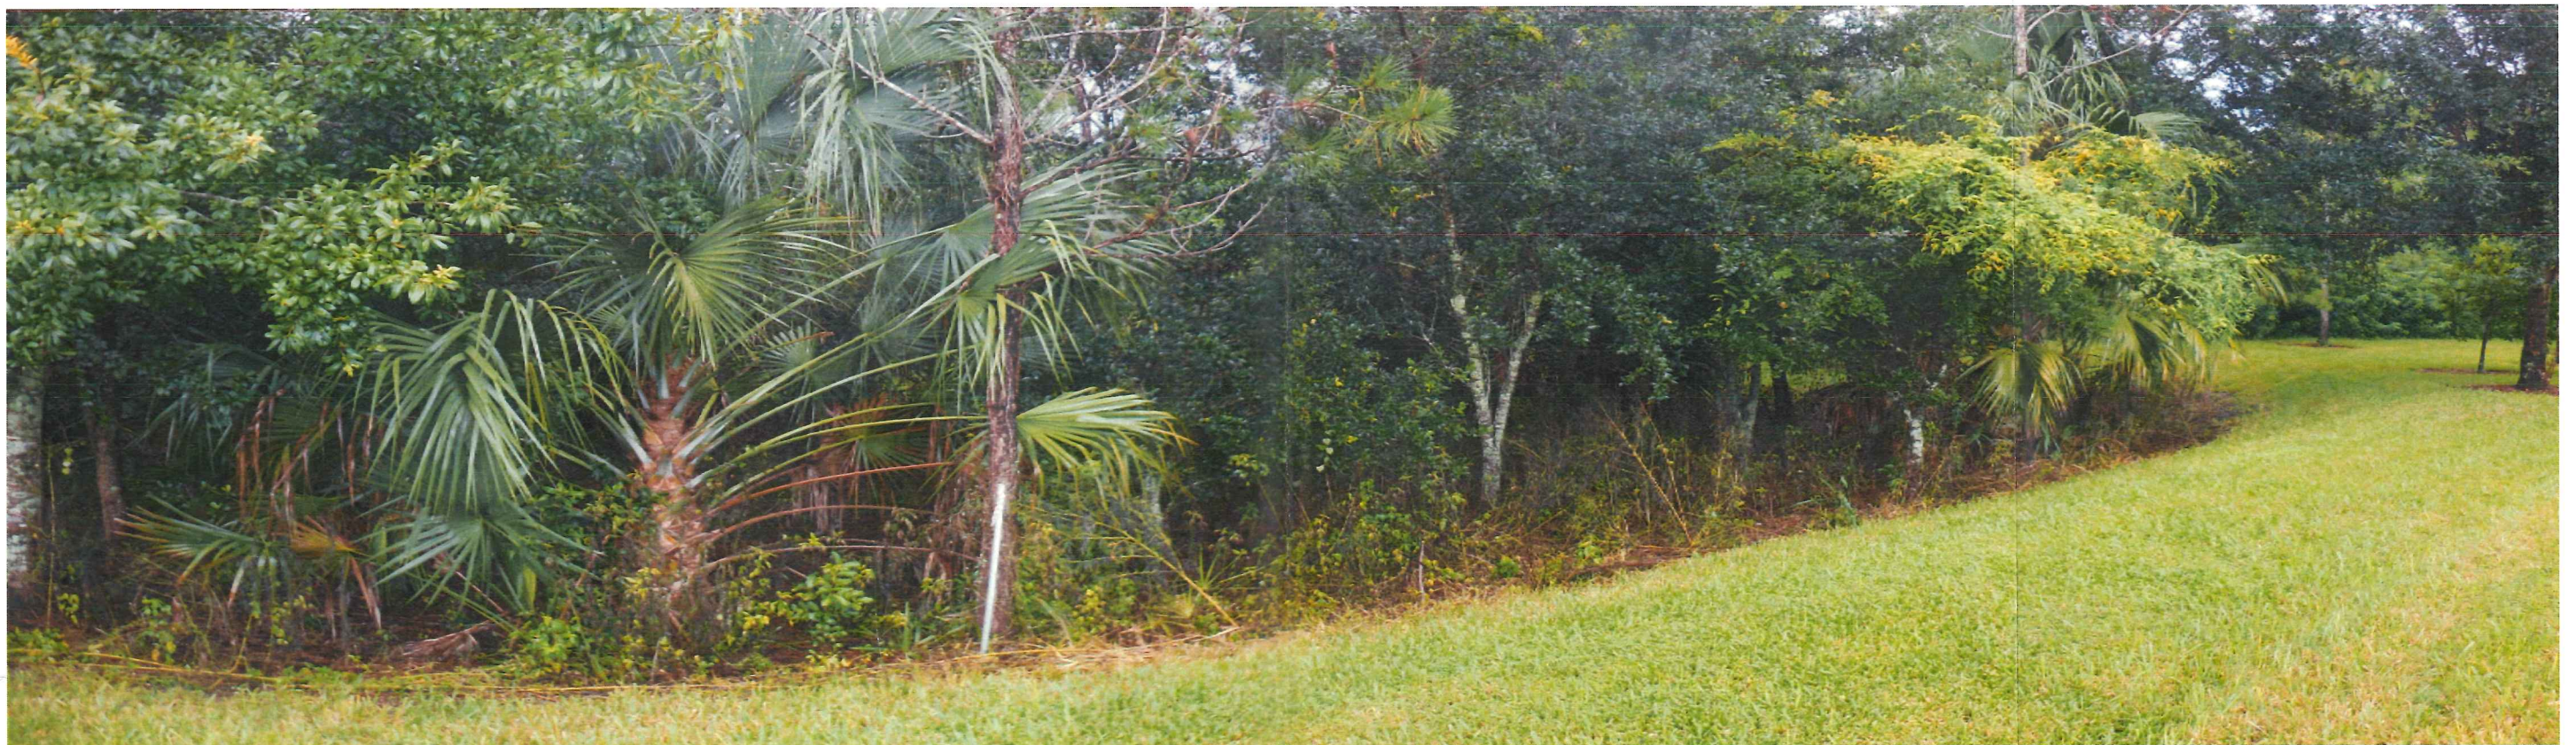
The last of the indigenous habitats preserved on site is located in the northeastern corner of the property. This small triangular-shaped area was also replanted to establish a native forested habitat. Live oak, slash pine, and cabbage palm were the canopy species

planted. Myrsine, saw palmetto, wax myrtle, and beautyberry were planted as shrubs. Groundcover species planted included sand cordgrass, Gulf muhly grass, beach dune sunflower, railroad vine, and three-awn grass. A dominance of the planted trees and shrubs has survived and are thriving. Some of the groundcover species have been replaced by broomsedge, carpetgrass and various sedges. The habitat is dominated by native plant species, as required in the development order.

Photo Station #10 – Indigenous Preserve D – (North half of preserve) - Looking Northeast

Photo Station #10 – Indigenous Preserve D – (South half of preserve) - Looking Southeast
