RE: **The Nest SWFL (formerly known as Eagle's Nest) - DCI2022-00004  
Planned Development Application RPD/CPD - Submittal 5  
(ABB PN: 20-0017)**

# The Nest

## Bald Eagle Management Plan

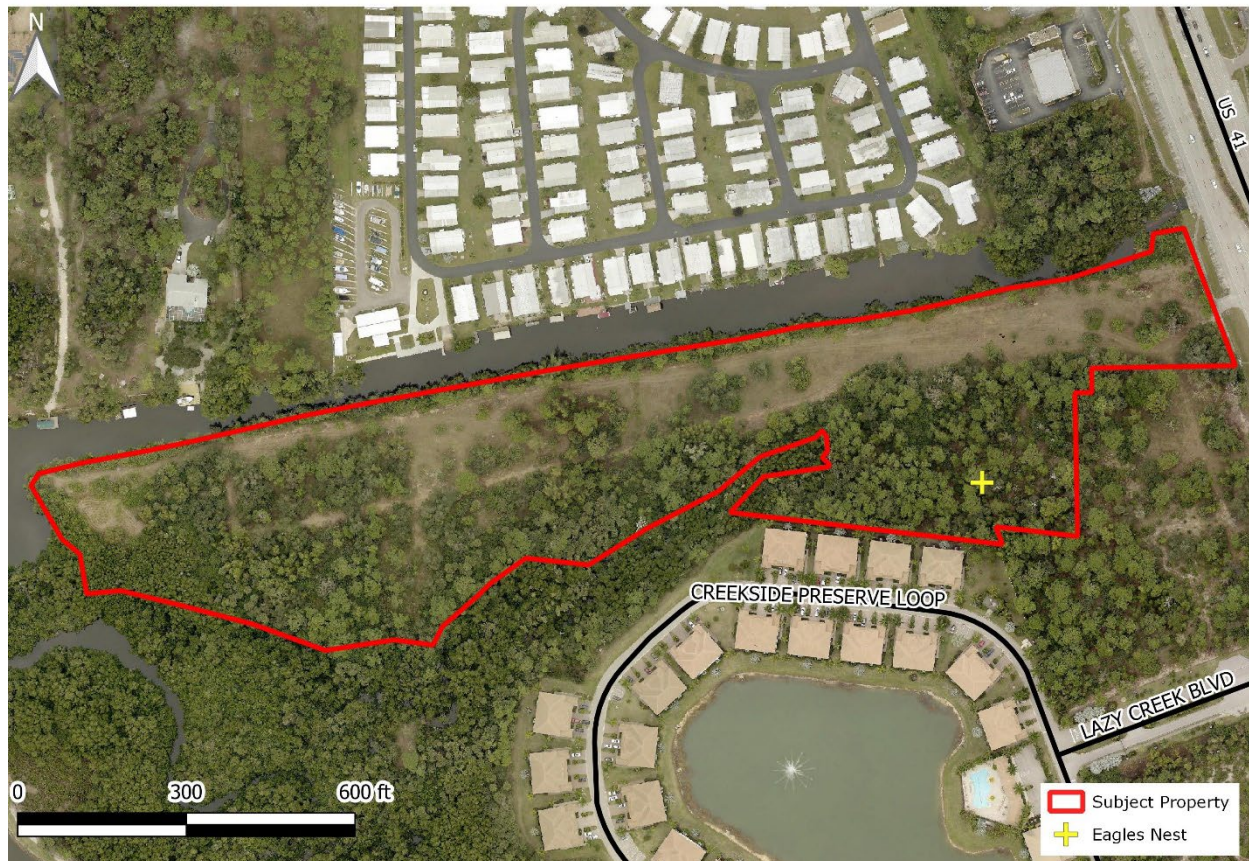
Figure 2. Aerial Map

The Subject Property contains both densely vegetated forests and areas of open improved pasture. Surrounding land use is residential to the north and south, with some commercial property across US 41. An aerial map can be seen in Figure 2.

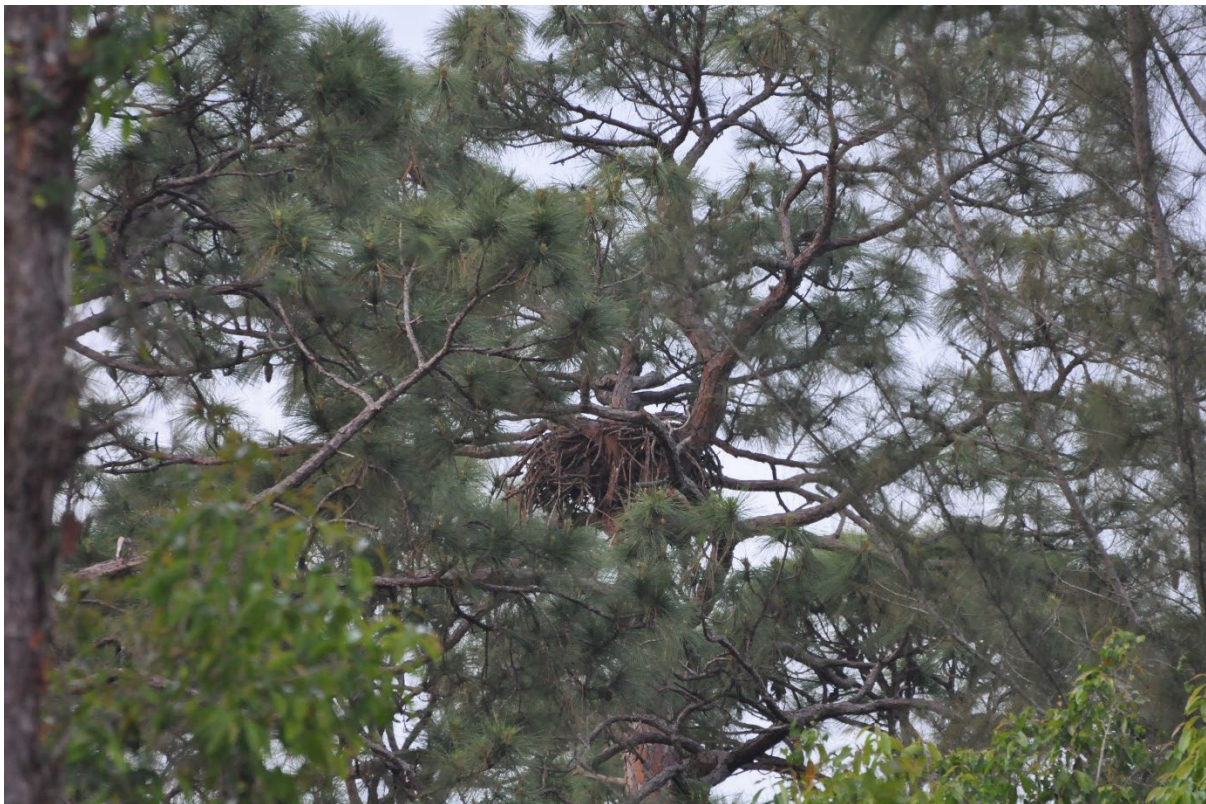
**Figure 5.** April 2020 Nest Condition

No eagles were observed in or around the nest in the months of April and May 2020. It is possible that monitoring began too late in the season and the bald eagle pair had concluded their nesting activities.

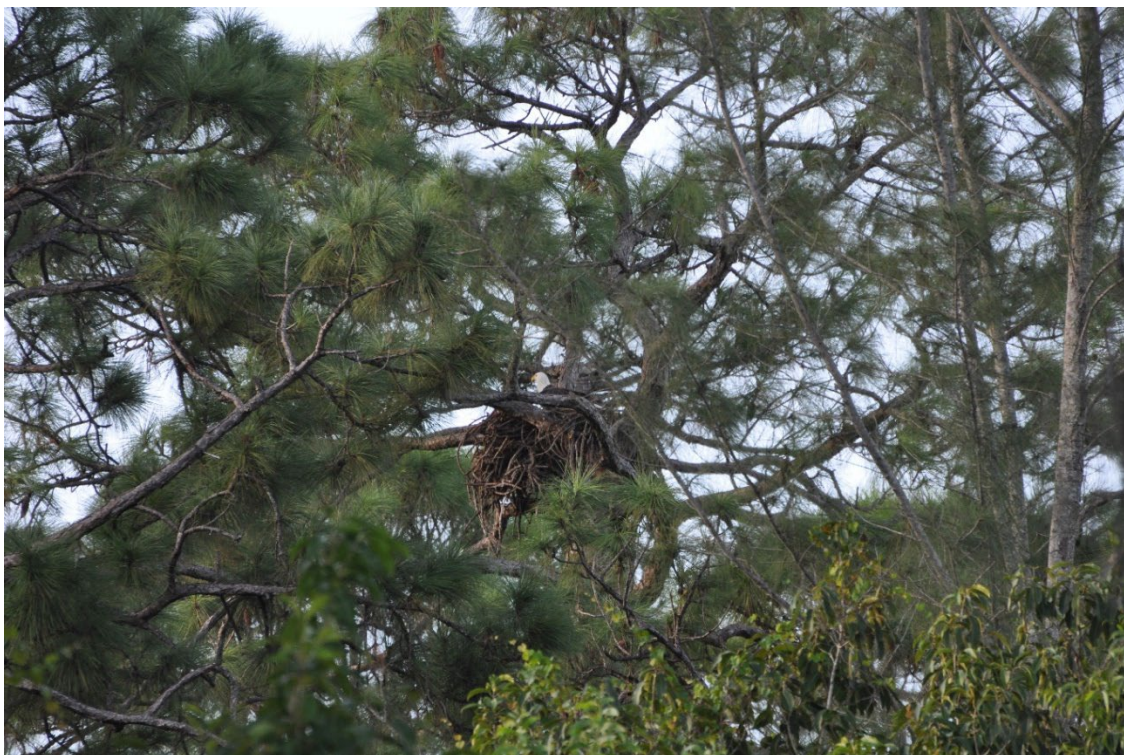
**Figure 6.** October 2020 Nest Condition (Eagle in Nest)

Monthly monitoring during nesting season began again in October 2020. An eagle was present in and around the nest in October and November 2020, but it was unclear if both members of the pair were present. In December 2020 the bald eagle pair was observed incubating eggs. The monthly monitoring was ended as these activities qualified the nest as an active nest for the nesting season.

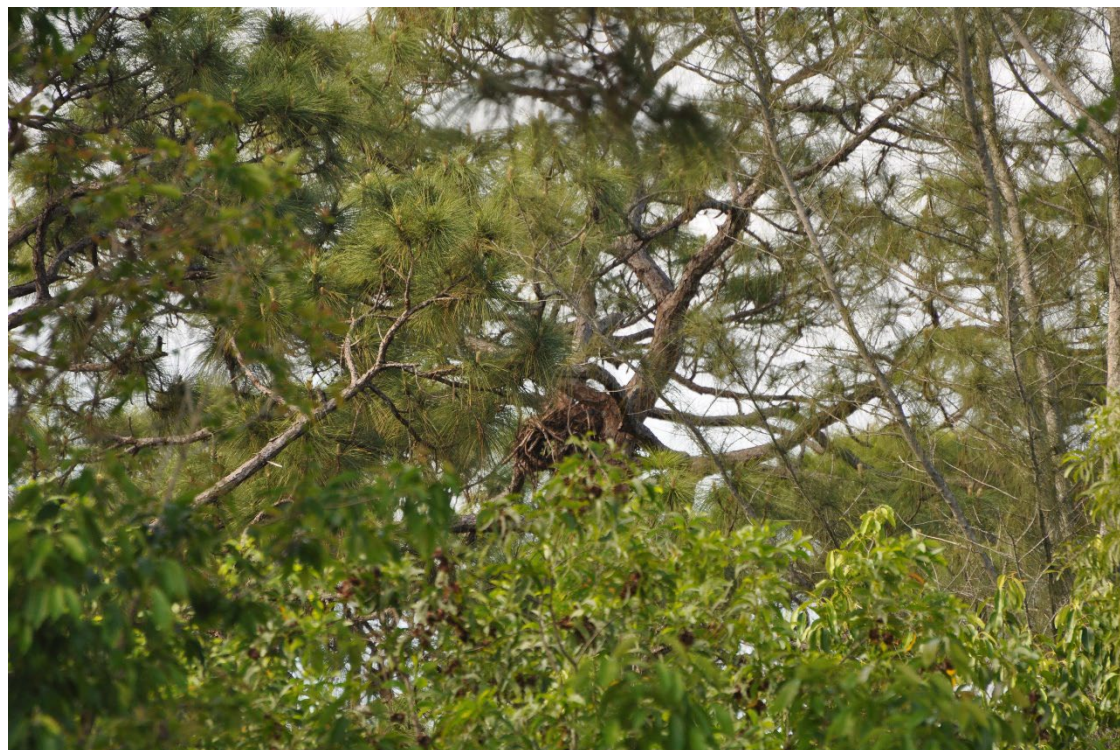
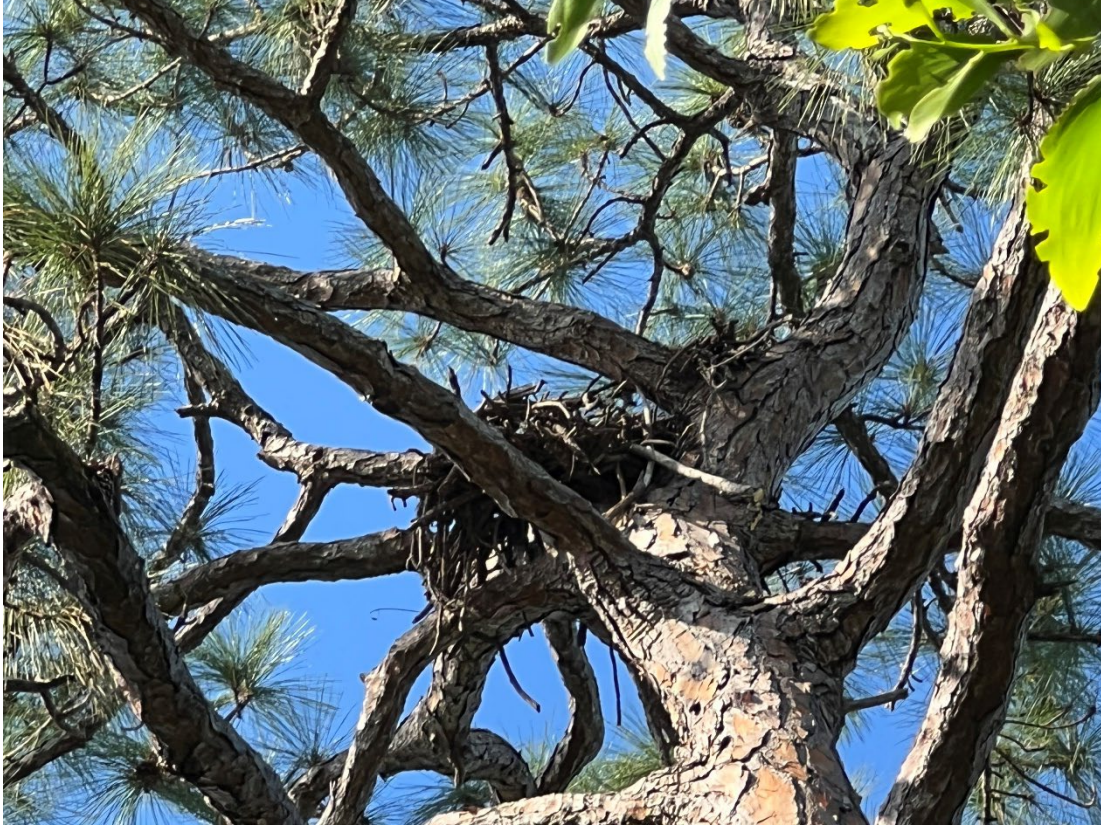
**Figure 7.** April 2022 Nest Condition

As of April 2022, the nest itself was small and the nest building that occurred during the 2020-21 season was minimal. The state of the nest was poor as of April 2022. The strong weather events that occurred during 2022 up to April has caused the nest to shift slightly and some of its mass had been lost. On closer inspection it appeared lopsided.

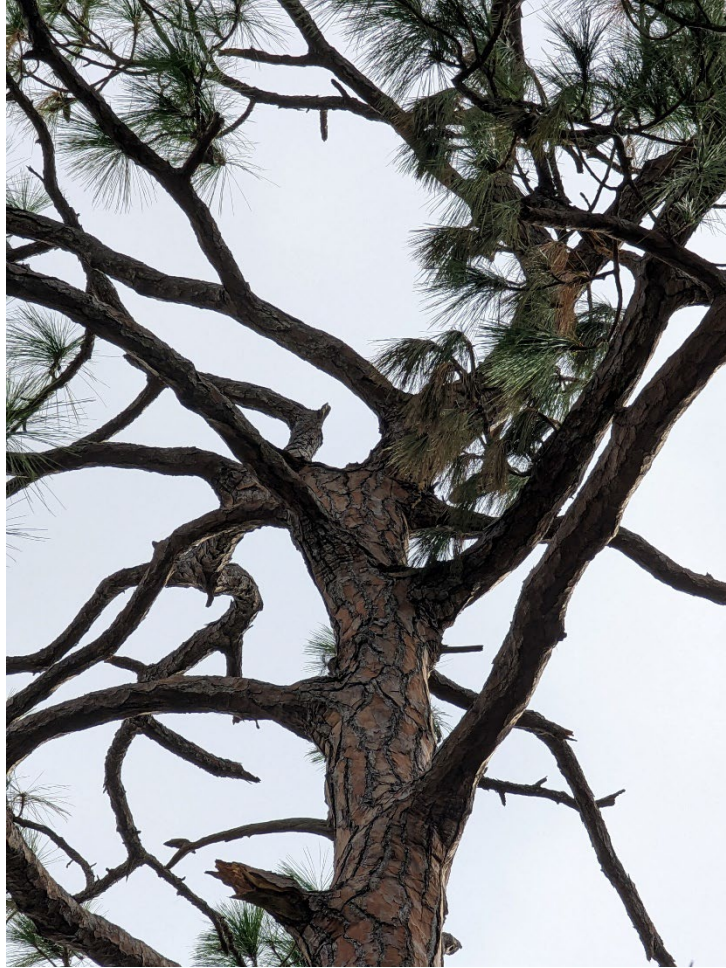
**Figure 9.** October 2022 Tree/Nest Condition

Hurricane Ian made landfall south of Punta Gorda on September 28, 2022. This catastrophic storm caused severe damage to the vegetative communities onsite including the nest tree. The nest tree sustained some damage with a large limb torn from the main trunk. The nest was completely blown down by the high winds.

***Hurricane Ian made landfall south of Punta Gorda on September 28, 2022. This catastrophic storm caused severe damage to the vegetative communities onsite including the nest tree. The nest tree sustained some damage with a large limb torn from the main trunk. The nest was completely blown down by the high winds.***

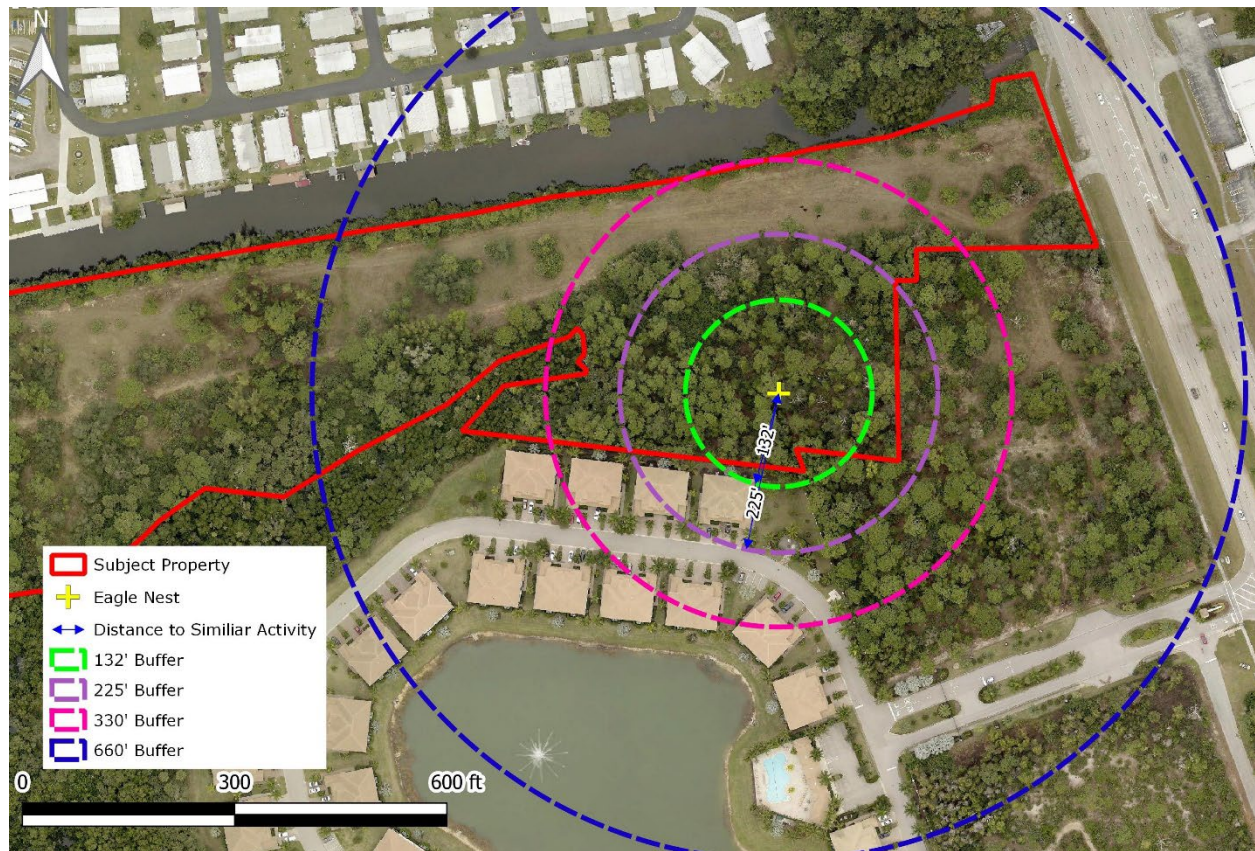
Figure 10. Bald Eagle Buffer Zones on Aerial

The nest tree is located 132' from the nearest existing residential building and 225' from the nearest existing road. Both of these activities are located in the neighborhood to the south, Creekside Preserve. Previous permitting for Creekside Preserve does not contain any mention of the nearby eagle's nest. The oldest record of the eagle's nest is from a 2015 listed species survey done on the Subject Property.

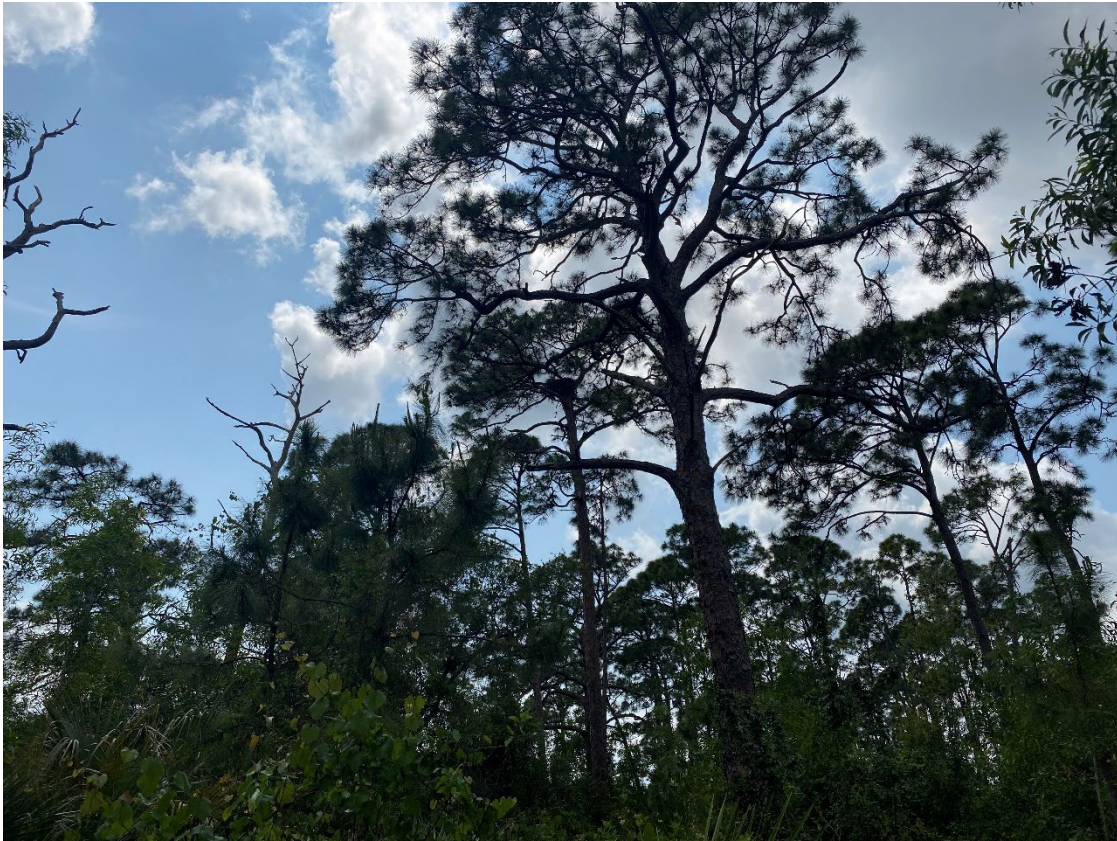
**Figure 13.** Pre-Ian view of the proposed upland preserve showing adult slash pine canopy. The eagle’s nest is in center frame and the photo was taken from the northeast.

A photo of the canopy pre-Hurricane Ian within the upland preserve can be seen in Figure 13.
