RESOLUTION OF THE BOARD OF COUNTY COMMISSIONERS  
OF LEE COUNTY, FLORIDA

WHEREAS, Matthew Slaughter filed an application on behalf of the property owner, STA FUND, LLC, to rezone a 15.75± acre parcel from Agricultural (AG-2) to Commercial Planned Development (CPD) and Residential Planned Development (RPD) in reference to The Nest SWFL; and

# SKETCH OF DESCRIPTION OF A TRACT OR PARCEL OF LAND LYING IN SECTION 17 AND 18, TOWNSHIP 46 SOUTH, RANGE 25 EAST, LEE COUNTY, FLORIDA

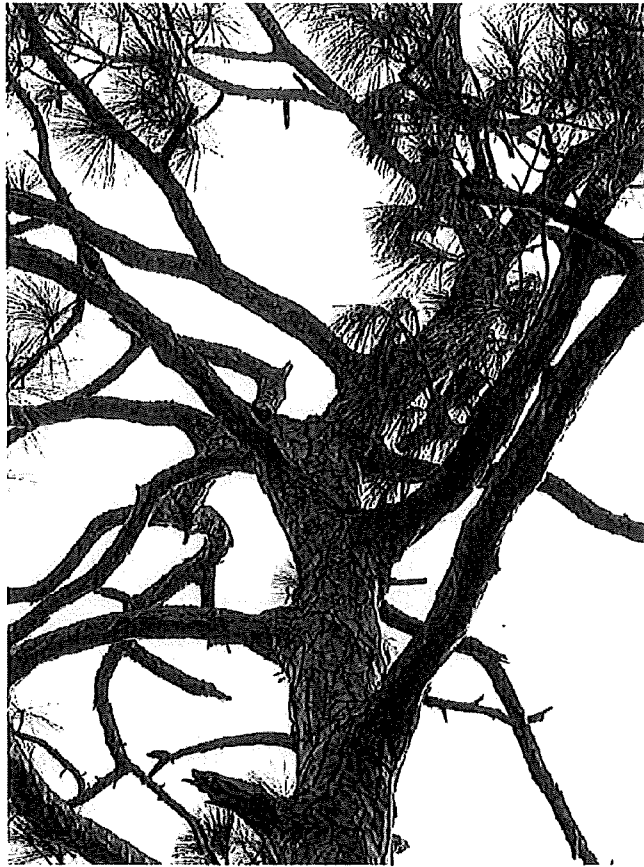
Figure 9. October 2022 Tree/Nest Condition

Hurricane Ian made landfall south of Punta Gorda on September 28, 2022. This catastrophic storm caused severe damage to the vegetative communities onsite including the nest tree. The nest tree sustained some damage with a large limb torn from the main trunk. The nest was completely blown down by the high winds.

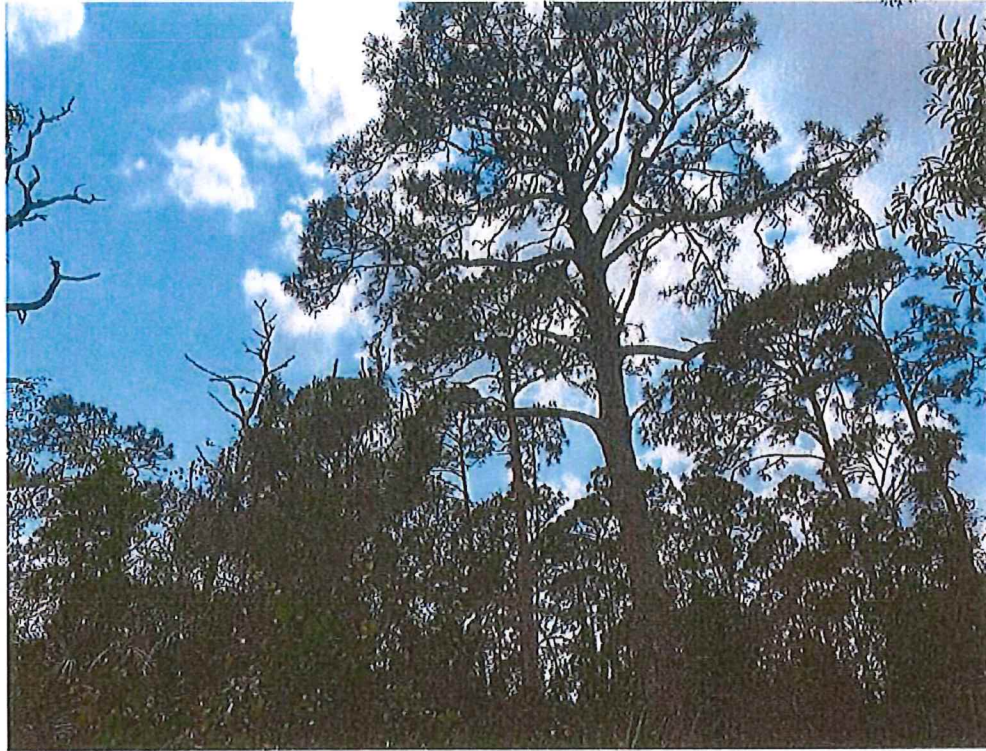
Figure 13. Pre-lan view of the proposed upland preserve showing adult slash pine canopy. The eagle's nest is in center frame and the photo was taken from the northeast.

If the nest is considered "lost" this Bald Eagle Management Plan and its conditions will not apply. A photo of the canopy pre-Hurricane Ian within the upland preserve can be seen in Figure 13.
