CPA 2022-00010

Re: **DANIELS TOWN SQUARE TEXT AND MAP AMENDMENTS
3rd INSUFFICIENCY RESPONSE LETTER
CPA2022-00010 AND CPA2022-00011**

Environmental Assessment
Daniels Town Square

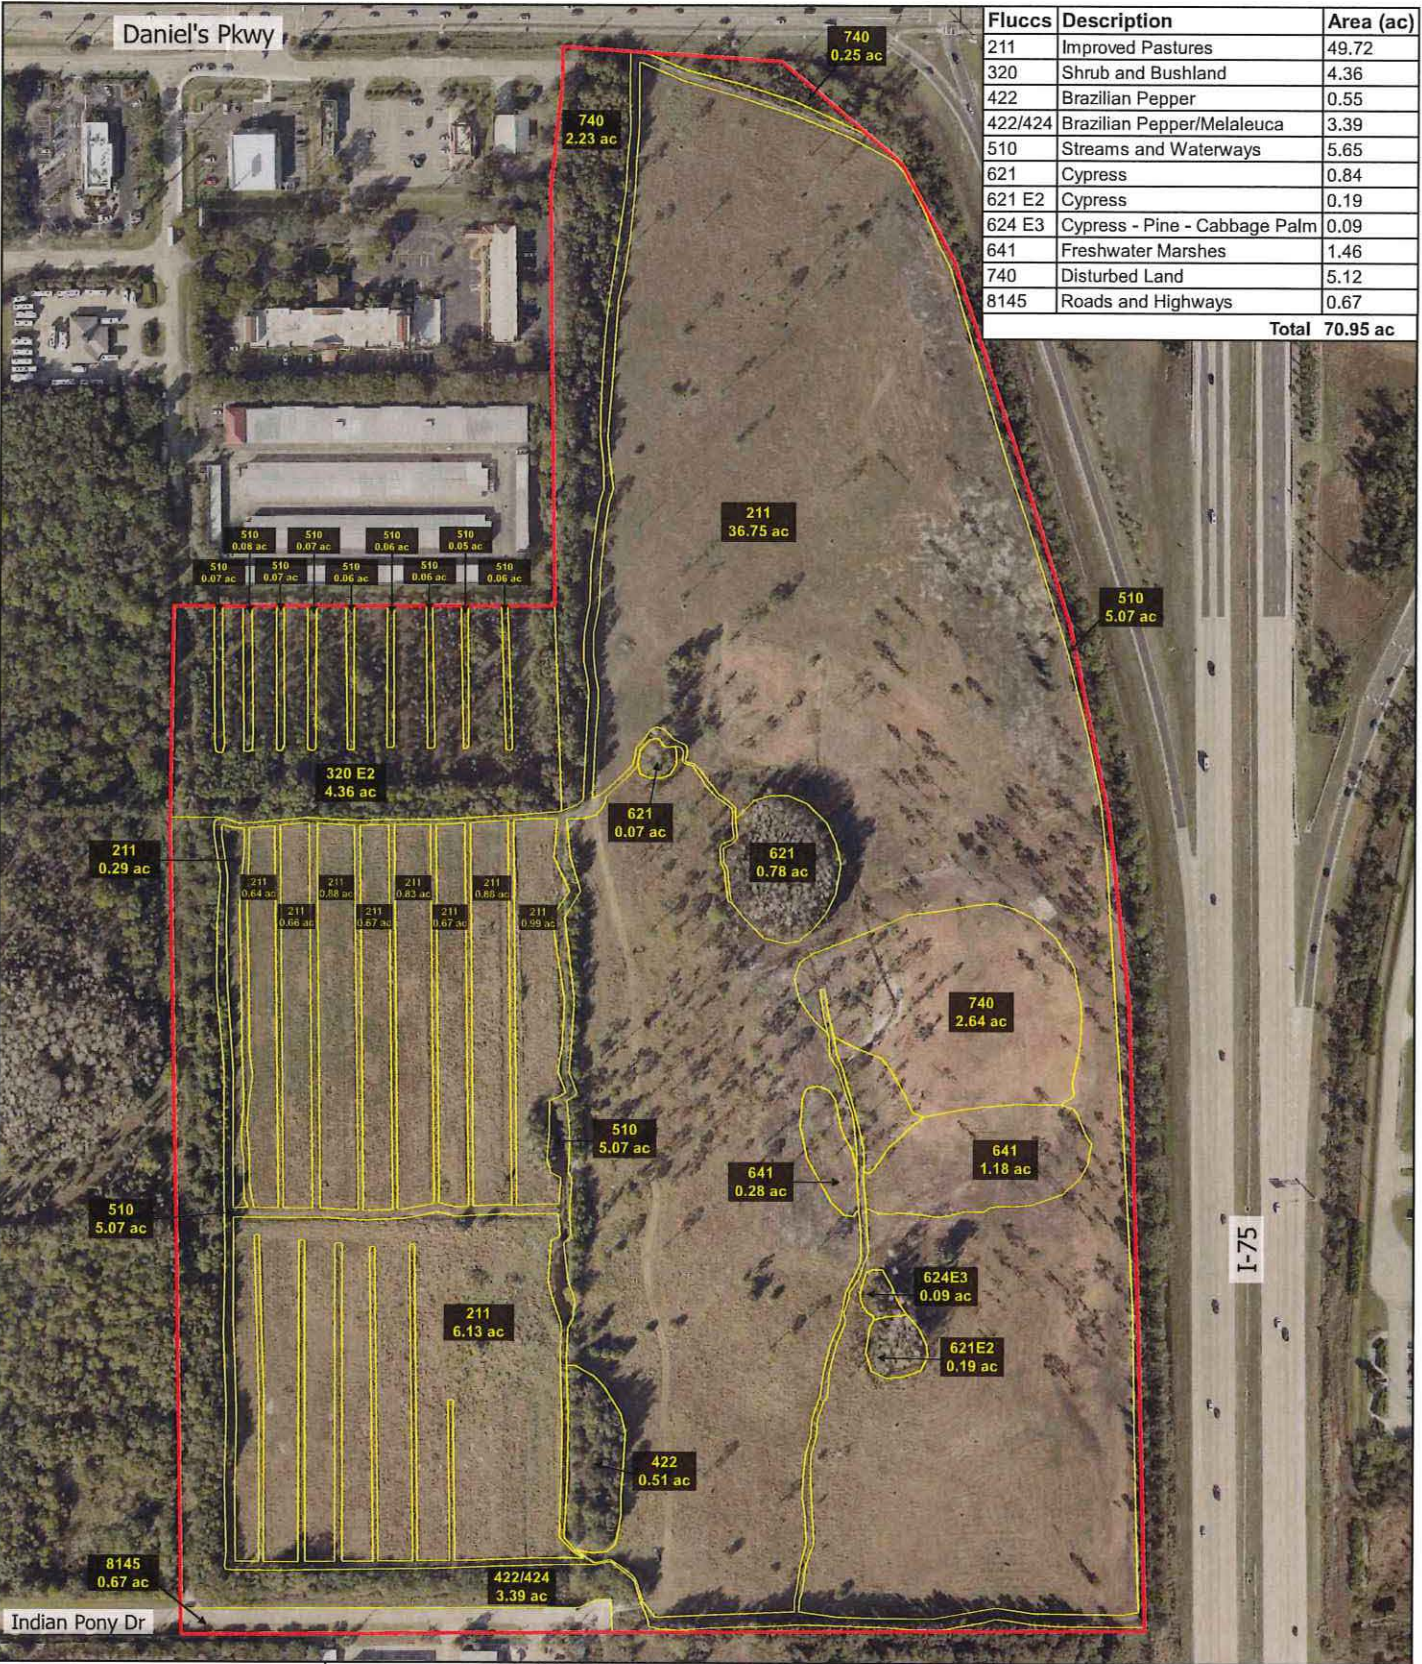
There are five upland land use types identified on this site. They are shown on the FLUCCS map that follows this page. They will be discussed in numerical order.

211 - Tame/Improved Pasture - The majority of this site was cleared in the past, once the *Melaleuca* infestation was removed, tame pasture forage grasses were planted. The site is a mixture of Bermudagrass and Bahia grass. The level of coverage is dependent on how long it has been since the areas were cleared. Those areas where exotic control was done first have the best coverage while those done last have the most sparse cover of forage grasses. The area west of the spine canal has been established for some time.

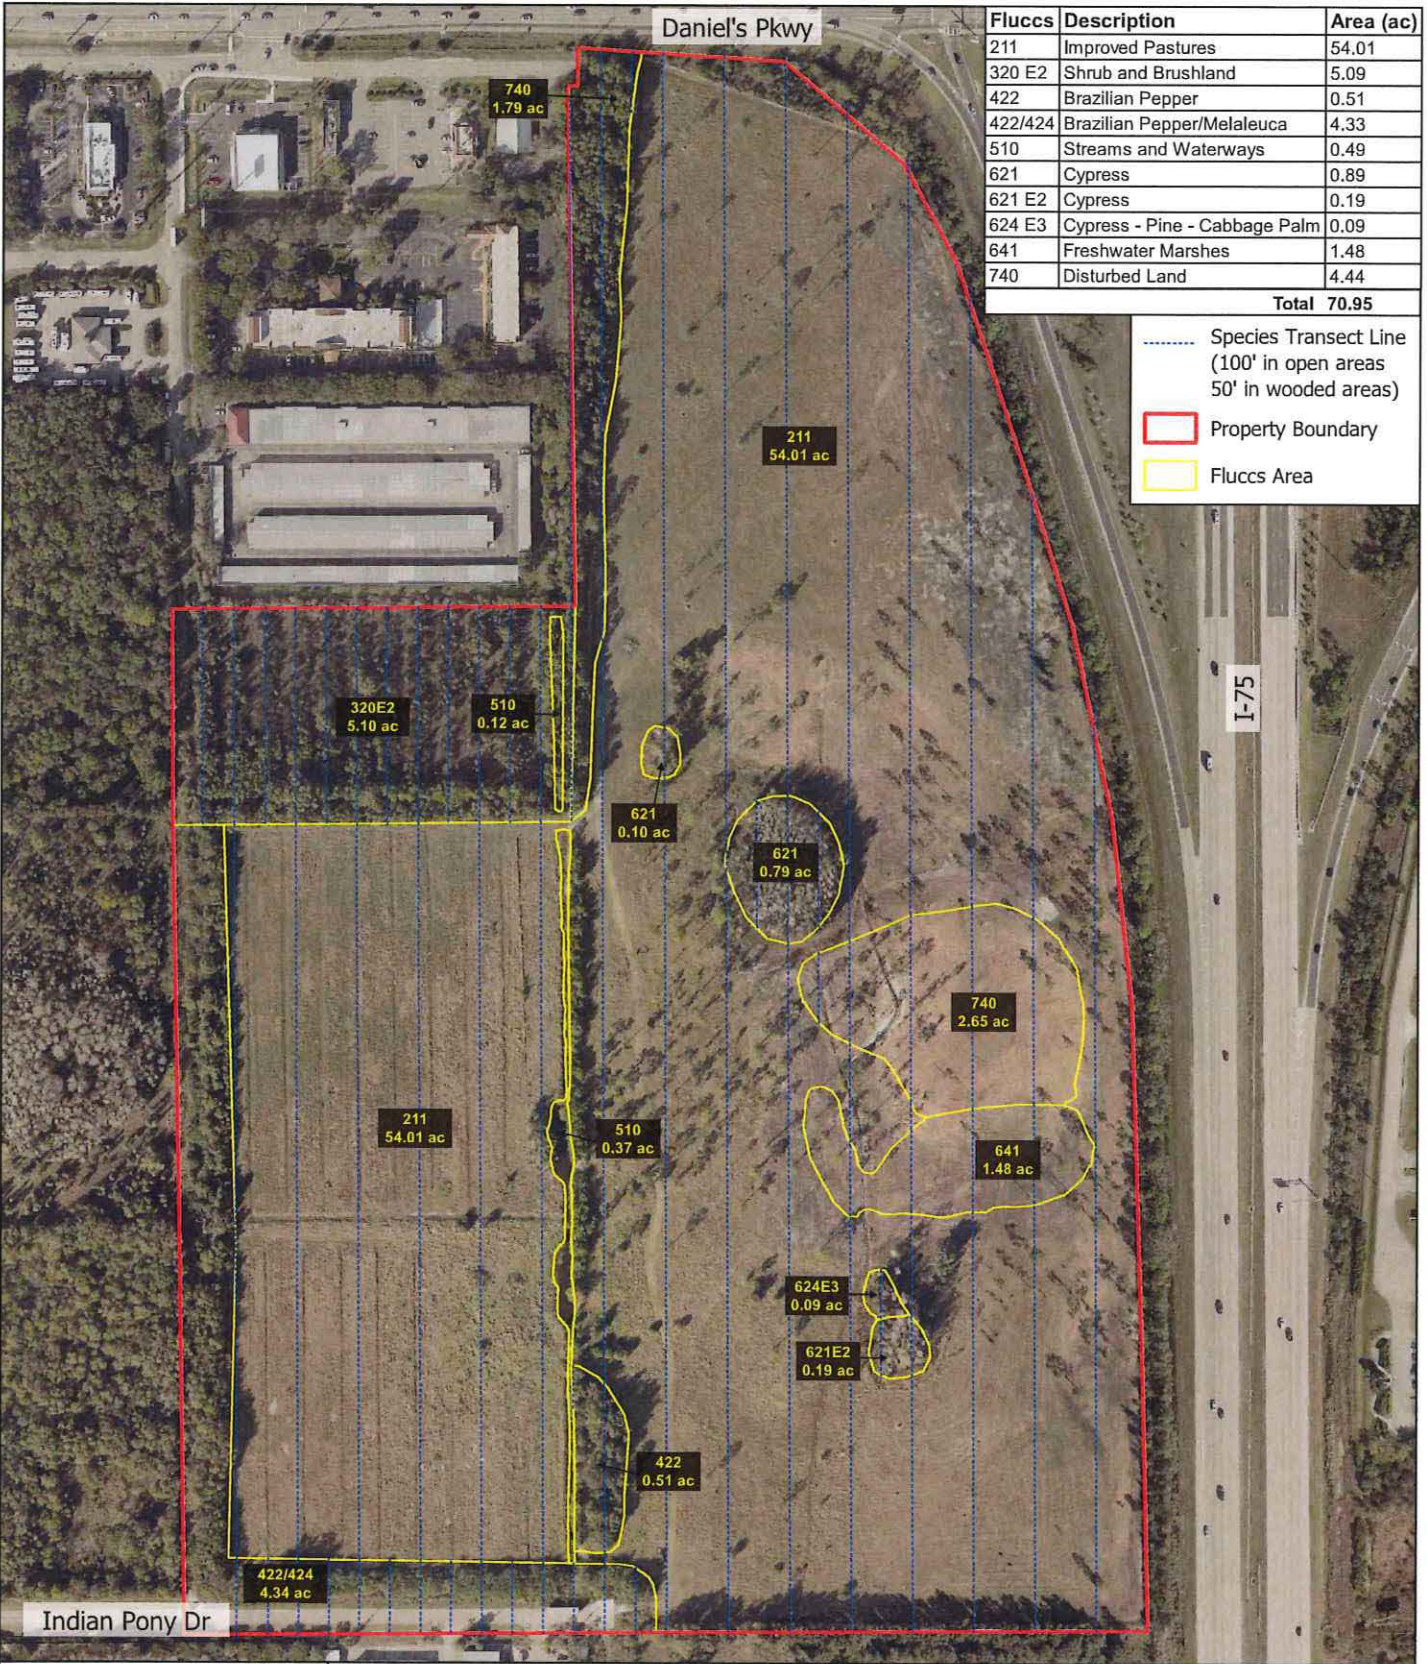
Fluccs	Description	Area (ac)
211	Improved Pastures	54.01
320 E2	Shrub and Brushland	5.09
422	Brazilian Pepper	0.51
422/424	Brazilian Pepper/Melaleuca	4.33
510	Streams and Waterways	0.49
621	Cypress	0.89
621 E2	Cypress	0.19
624 E3	Cypress - Pine - Cabbage Palm	0.09
641	Freshwater Marshes	1.48
740	Disturbed Land	4.44
Total		70.95

- Species Transect Line (100' in open areas
50' in wooded areas)
- Property Boundary
- Fluccs Area

The entire project site was field surveyed for protected species in Compliance with the Lee County Endangered Species Ordinance No. 89-34 using the Southern Biomes wandering transect method this is also consistent with the Florida Game and Fresh Water Fish Commission. Transect widths of 100' were adequate to survey the entire. In addition to the transect observations, unvegetated sandy areas near the fence lines were checked for sign early in the morning. The site was observed aerially by drone to check for additional indicators. Because the entire site was surveyed completely concerns regarding small linear communities and ecotonal areas were addressed thoroughly. The Transect Location Map shows survey transects. The straight lines depict the center of the wandering transects.

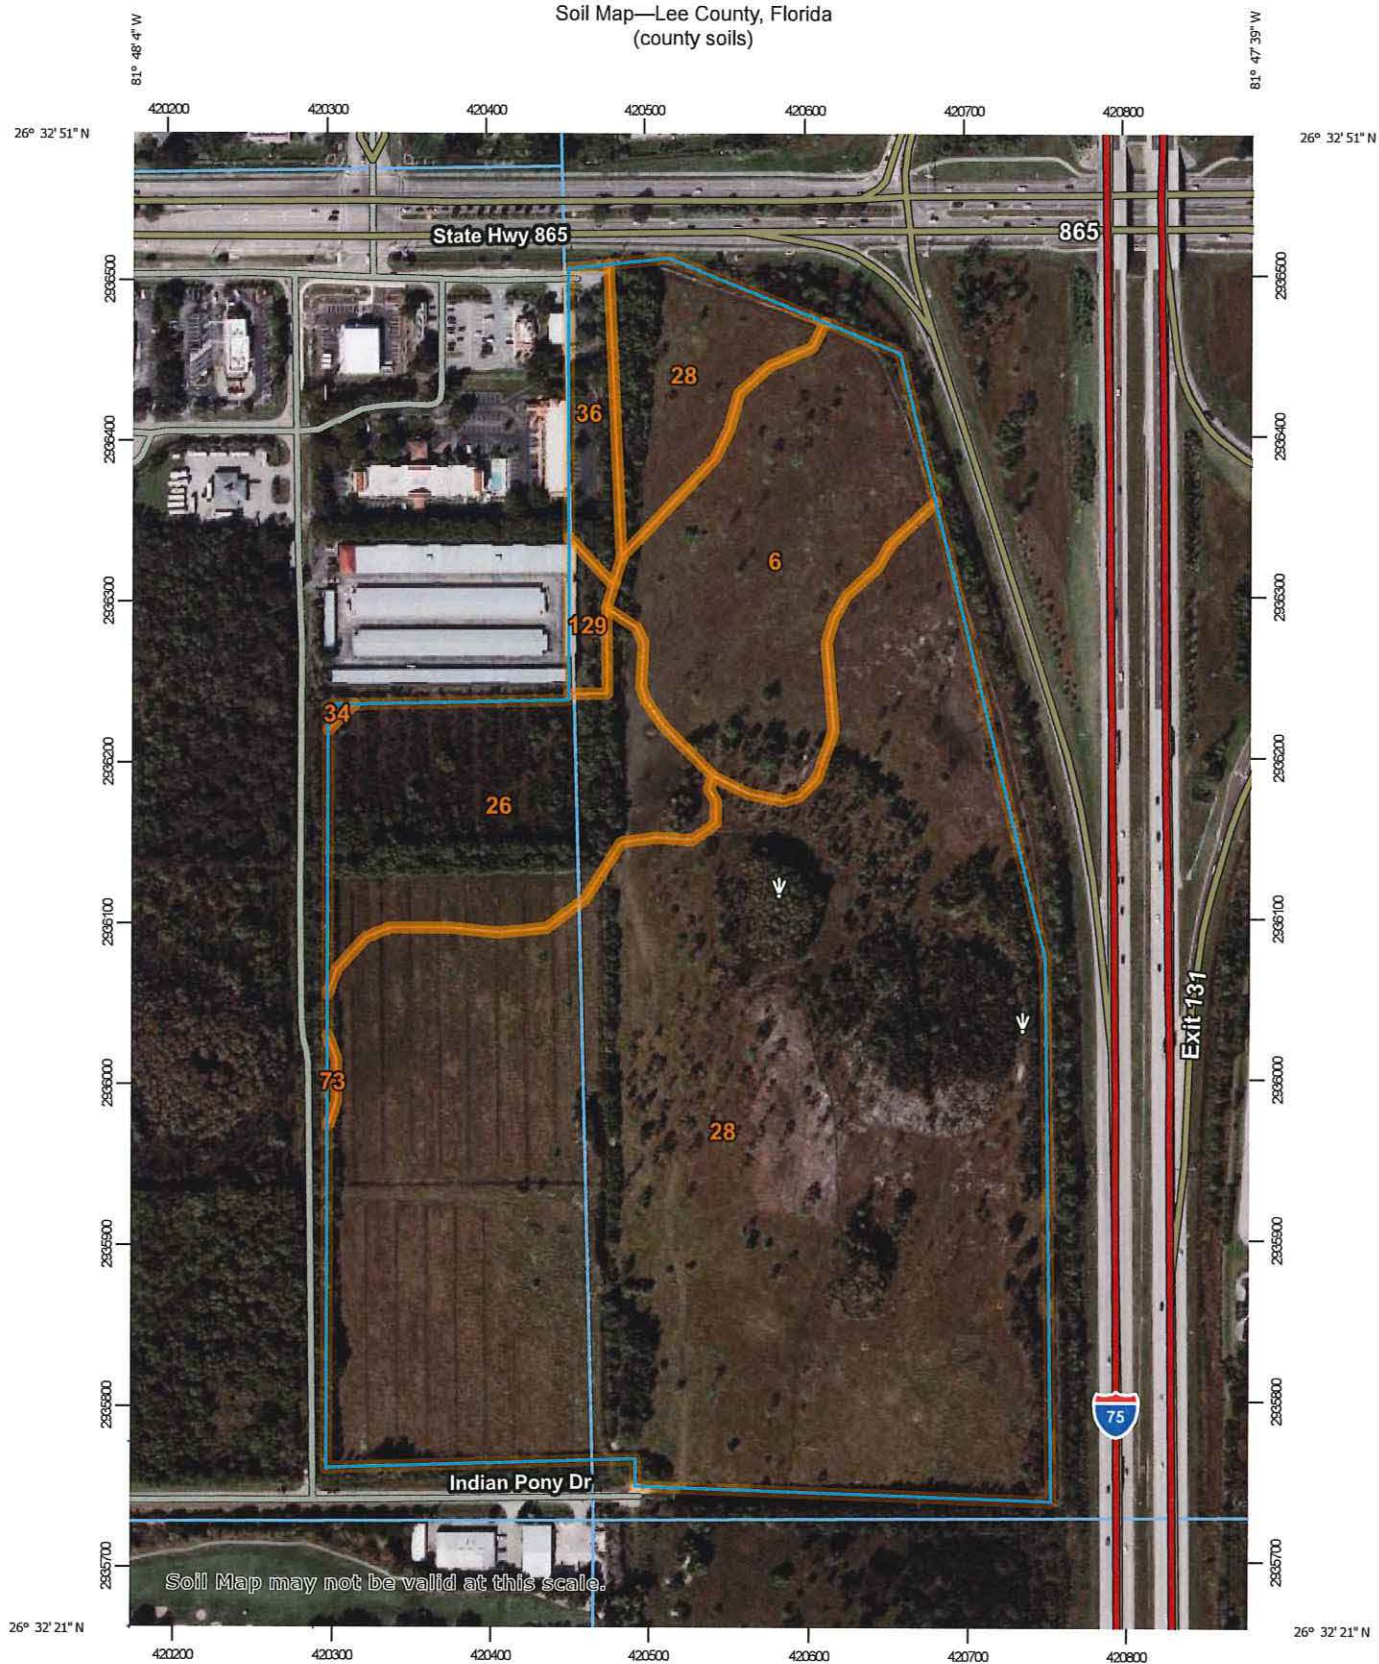
Soil Map—Lee County, Florida (county soils)

Soil Map may not be valid at this scale.

Map Scale: 1:4,540 if printed on A portrait (8.5" x 11") sheet.

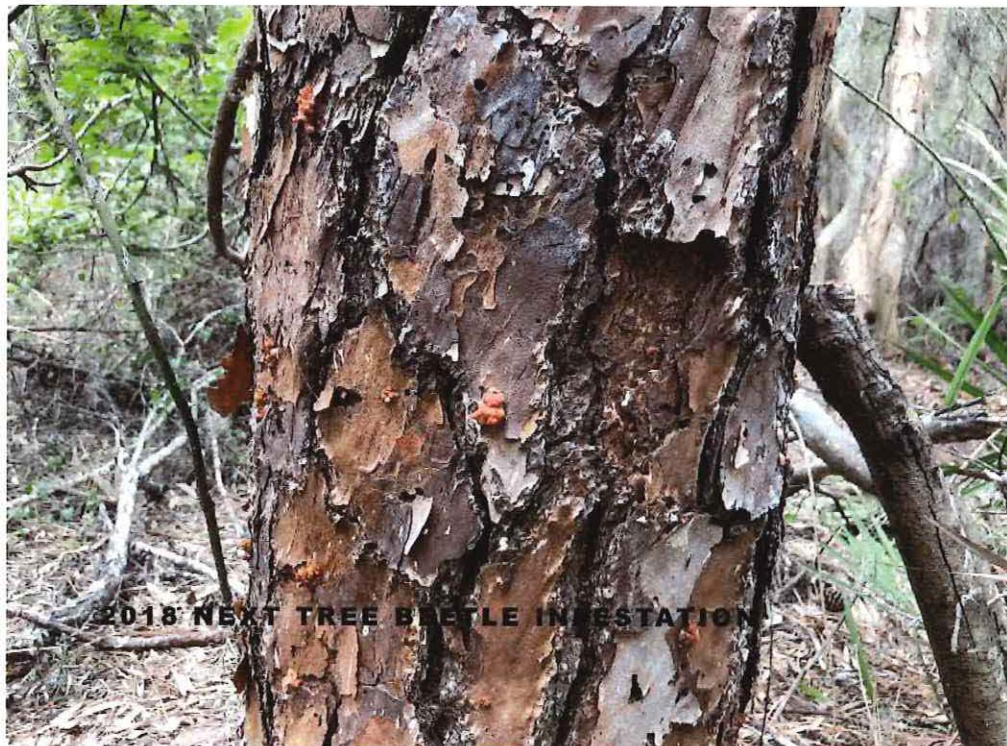
2018 NEST TREE PHOTO SHOWING BEETLE INFESTATION

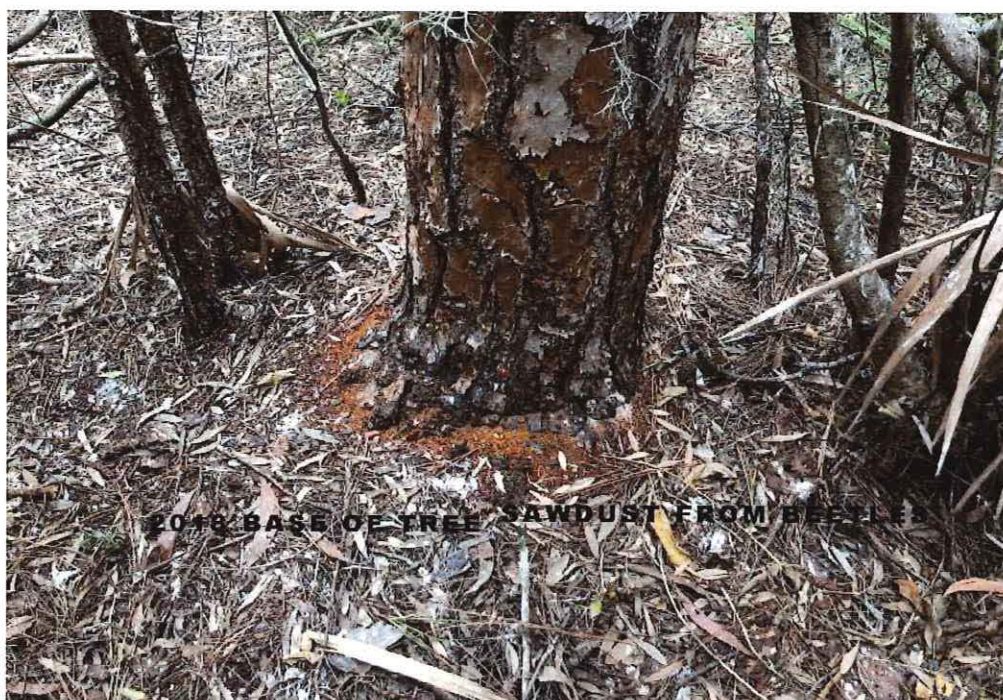
2018 BASE OF NEST TREE - NOT BEETLE - RELATED SAWDUST

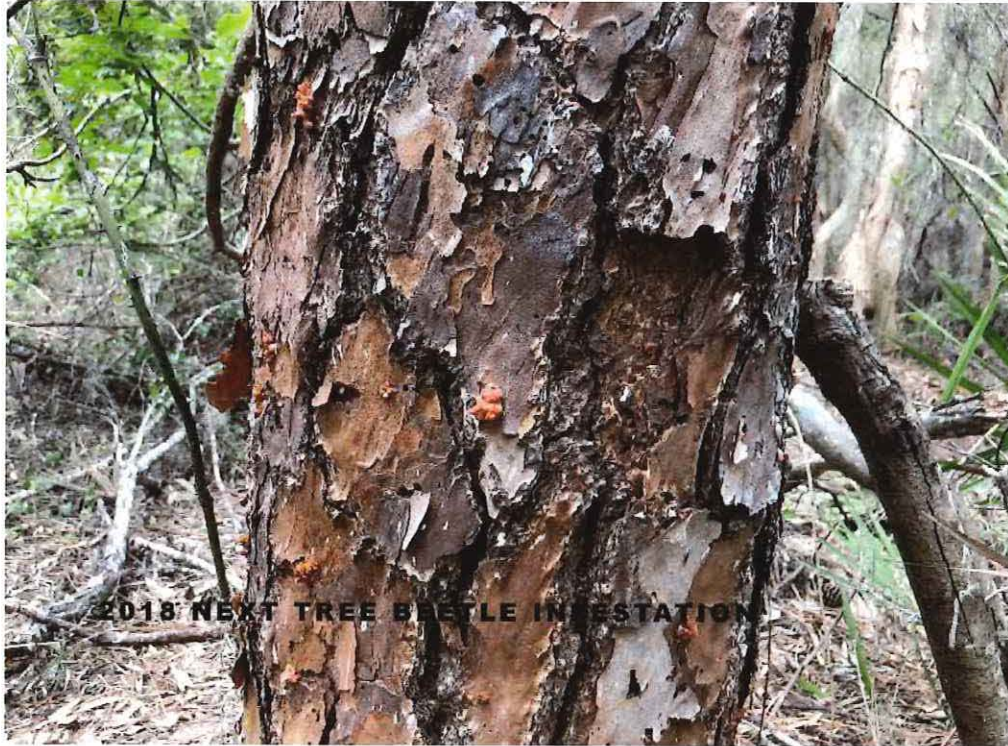
2018 NEST TREE PHOTO SHOWING BEETLE INFESTATION

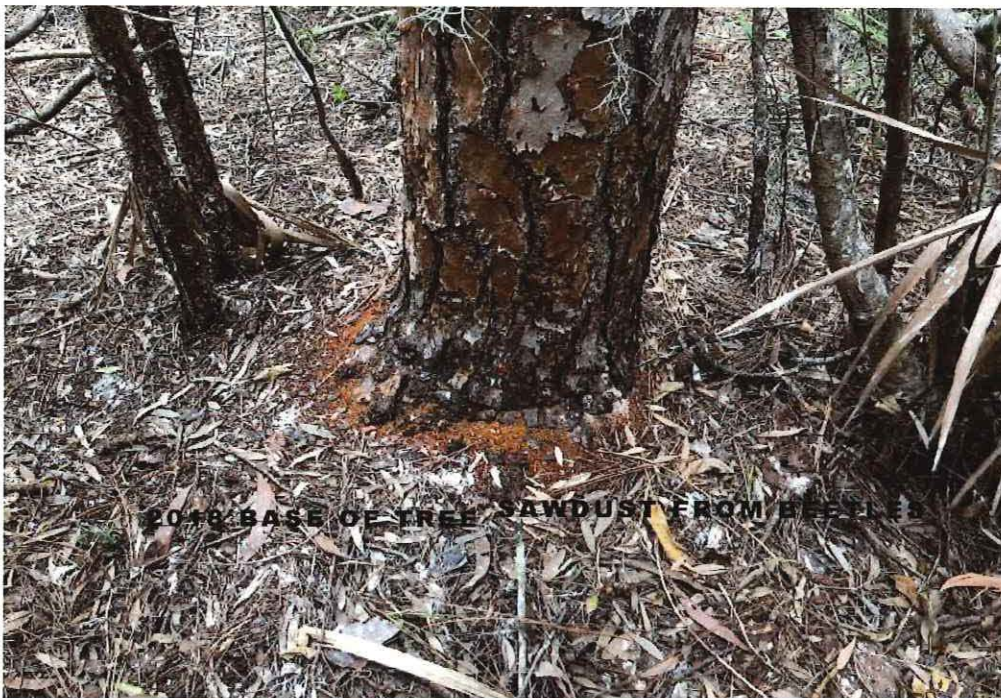
2018 BASE OF NEST TREE - NOT BEETLE - RELATED SAWDUST
